**THE IMPACT OF RIVER REHABILITATION ON  
FLOOD MITIGATION:  
A CASE STUDY OF ISMETIYE CREEK BURSA**

YÜKSEK LİSANS TEZİ  
İNŞAAT MÜHENDİSLİĞİ ANABİLİM DALI

BURSA – 2022  
**Her Hakkı Saklıdır**

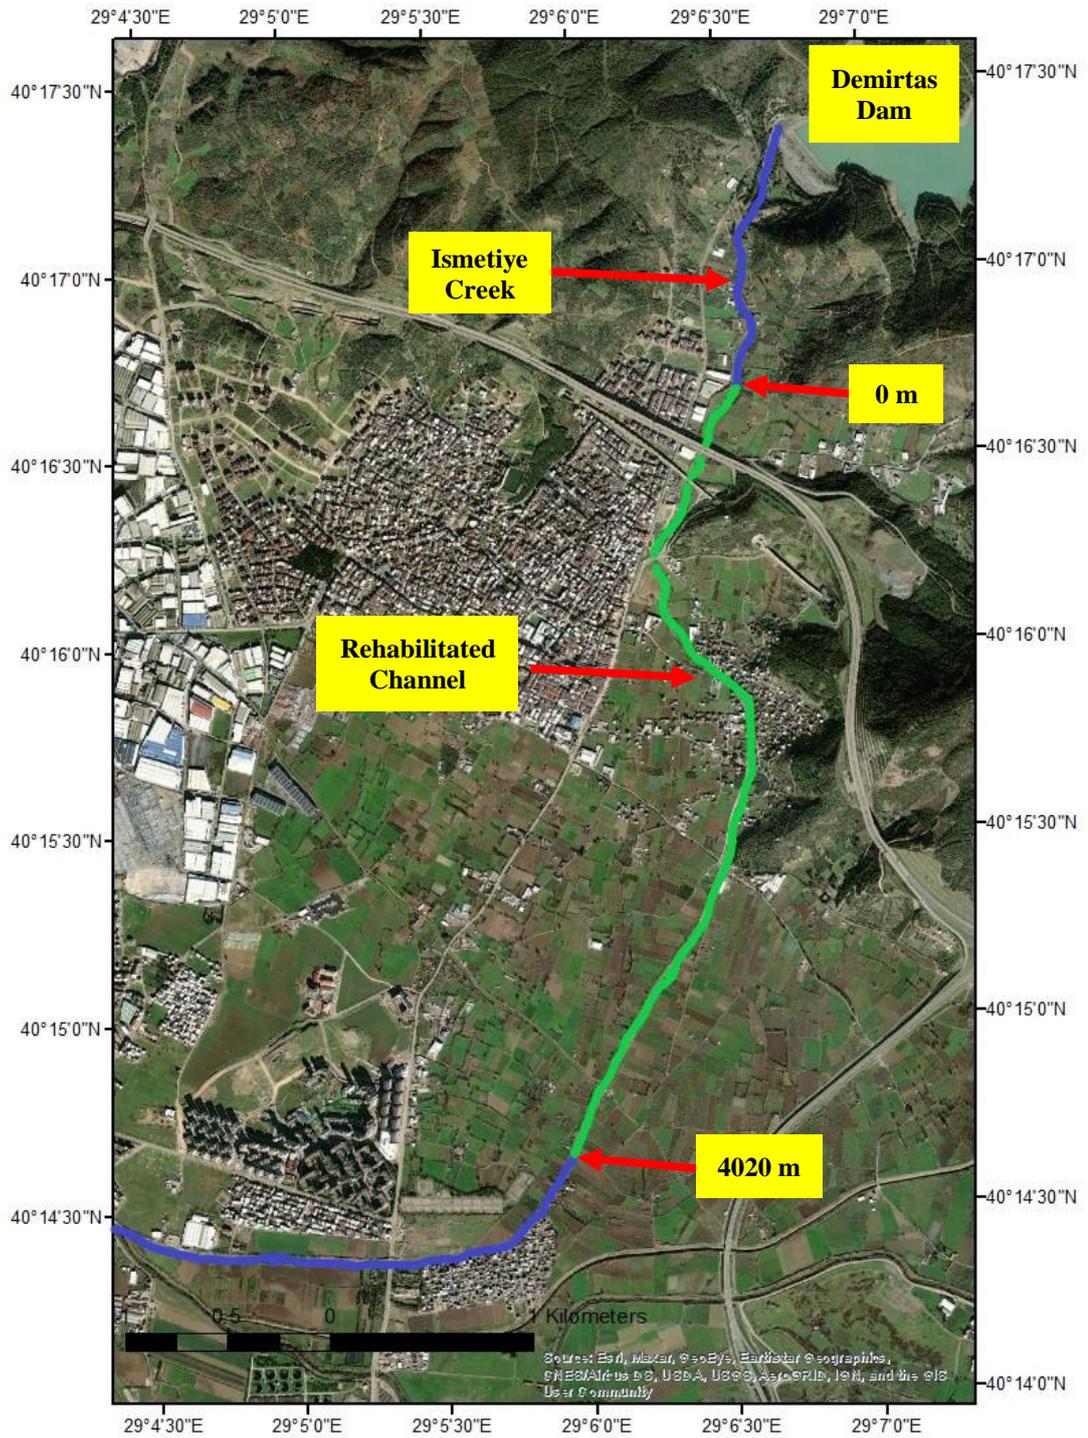
**Figure 3.1.** Map showing Demirtas dam, Ismetiye creek (marked in blue) and the rehabilitated part (marked in green) of channel.

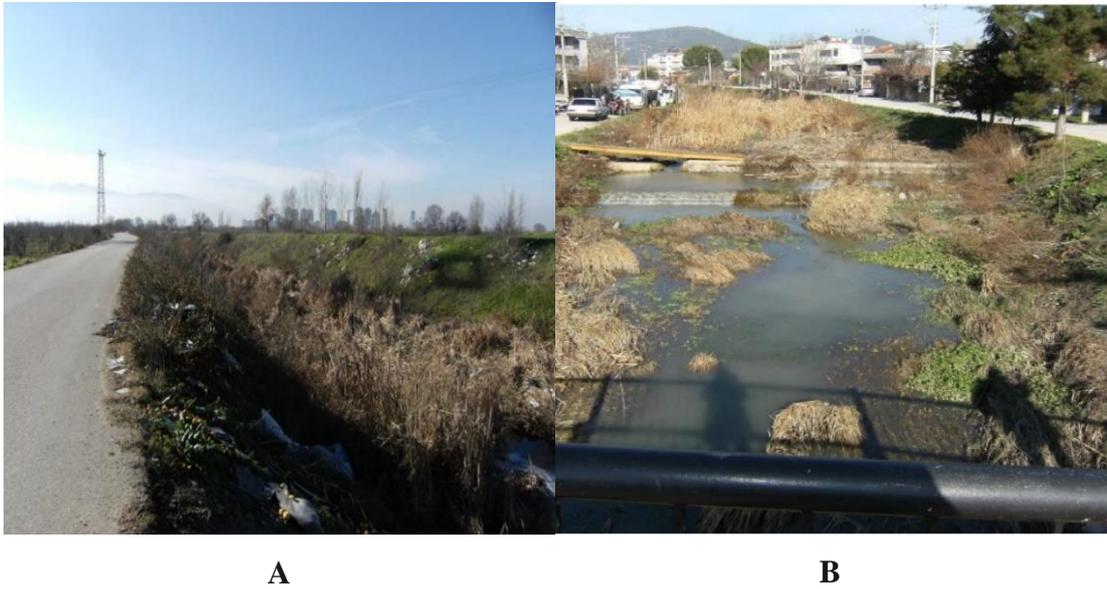
Ismetiye creek, in its natural state before rehabilitation, was more prone to flood risk. Figure 3.2 shows Ismetiye creek in its natural state.

**Figure 3.2.** Ismetiye creek in its natural state (BUSKI Report, 2013) **A)** downstream view at the end of Ismetiye village **B)** upstream view inside Ismetiye village

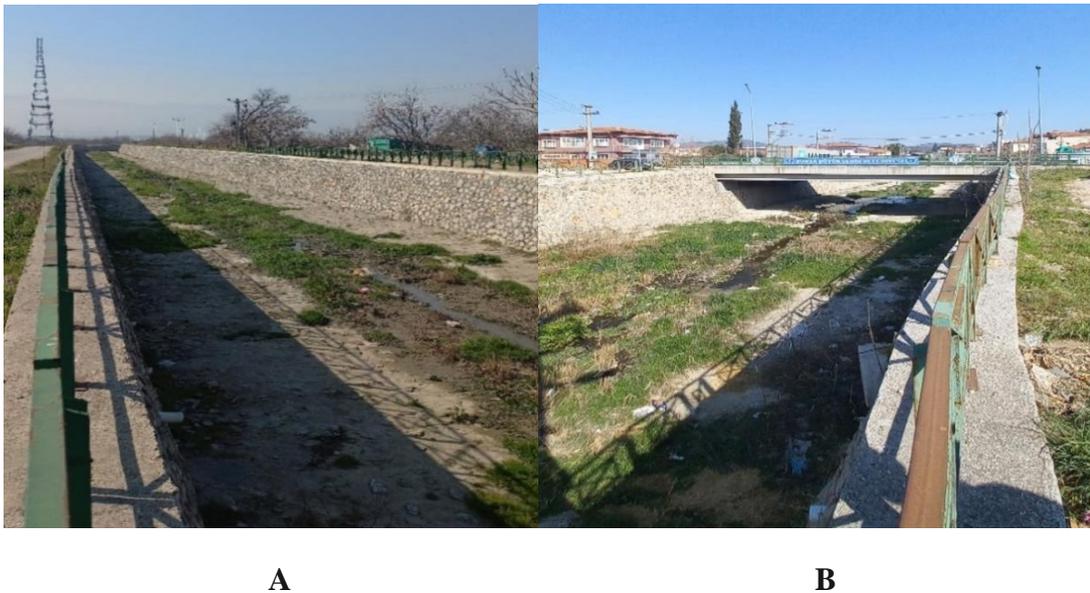
The rehabilitation work was started by BUSKI in the year 2013 and finished in 2017. Figure 3.3 shows Ismetiye creek in its rehabilitated state as of March, 2022.

**Figure 3.3.** Ismetiye creek in its rehabilitated state **A)** downstream view at the end of Ismetiye village at X =3500 m **B)** upstream view inside Ismetiye village at X= 2500 m

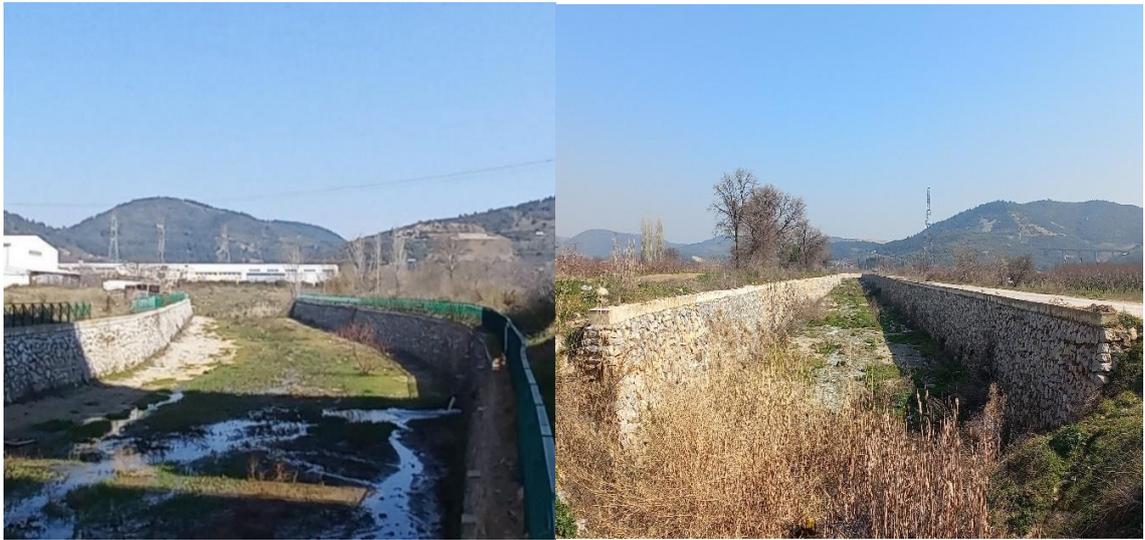
Figure 3.4 shows Ismetiye creek at the beginning and end points of rehabilitation

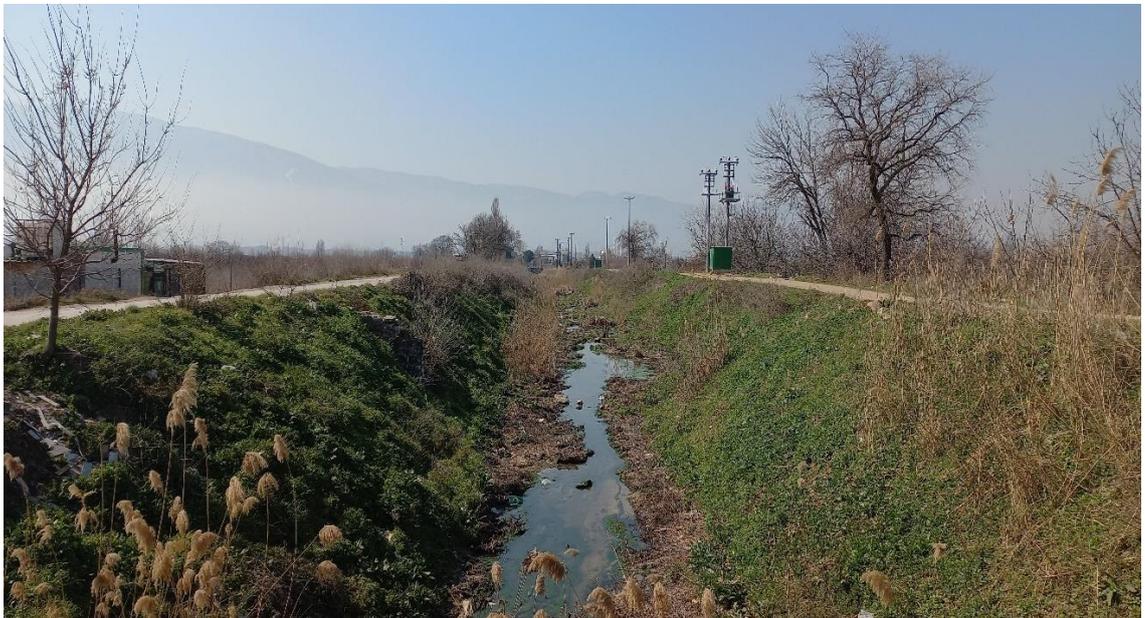
Figure 3.5 shows Ismetiye creek in its natural state as seen from the spot where rehabilitation work was stopped.

**Figure 3.5.** Downstream view of Ismetiye creek at 4020 m

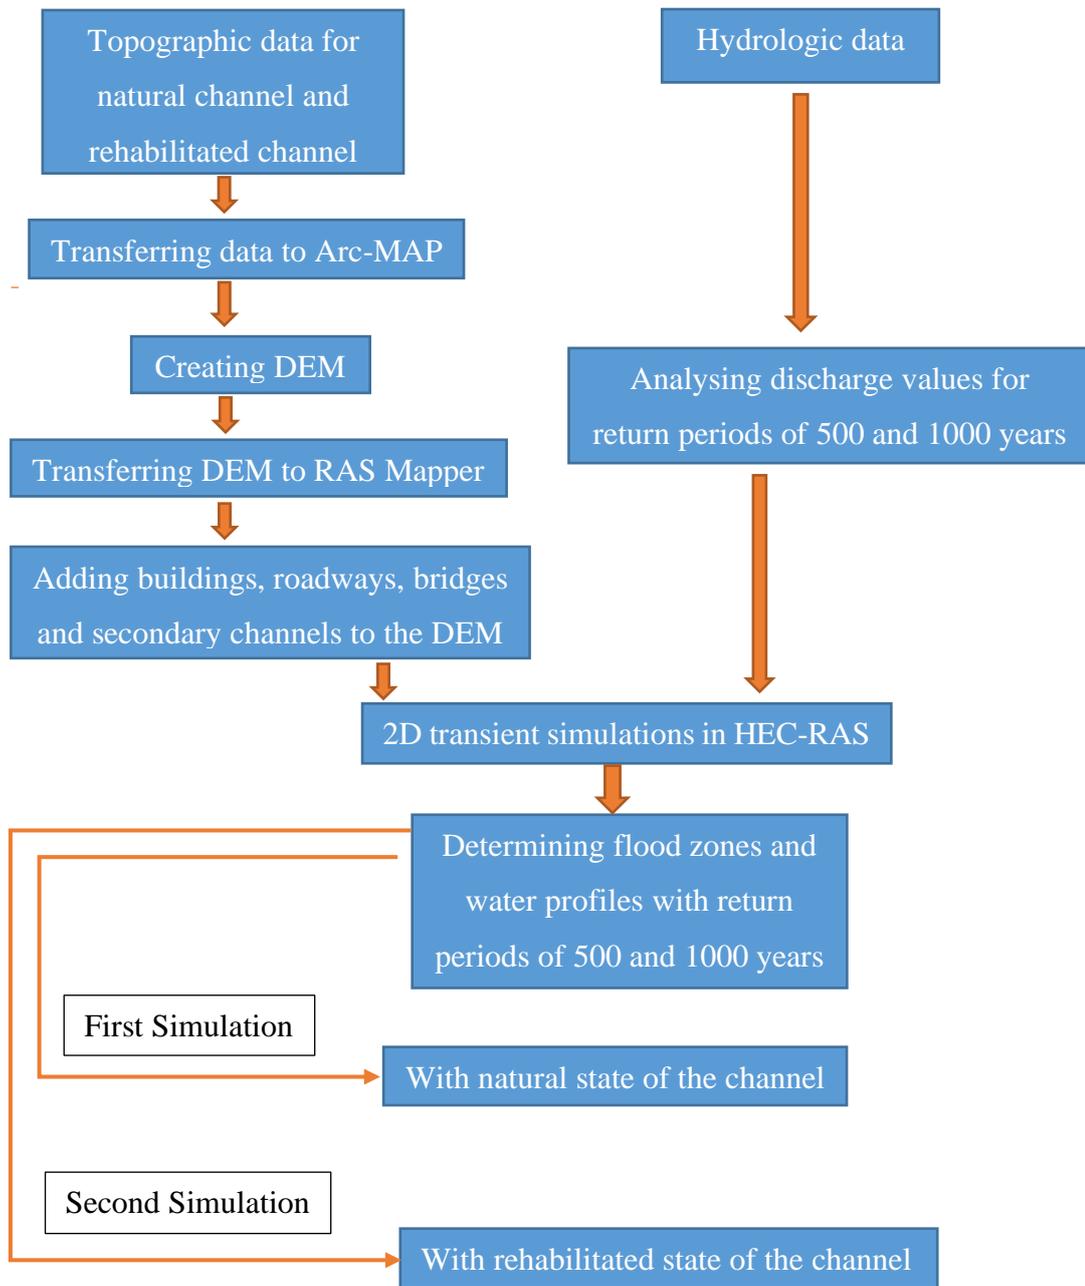
**Figure 3.6.** Methodology adopted to perform the flood simulations in this study

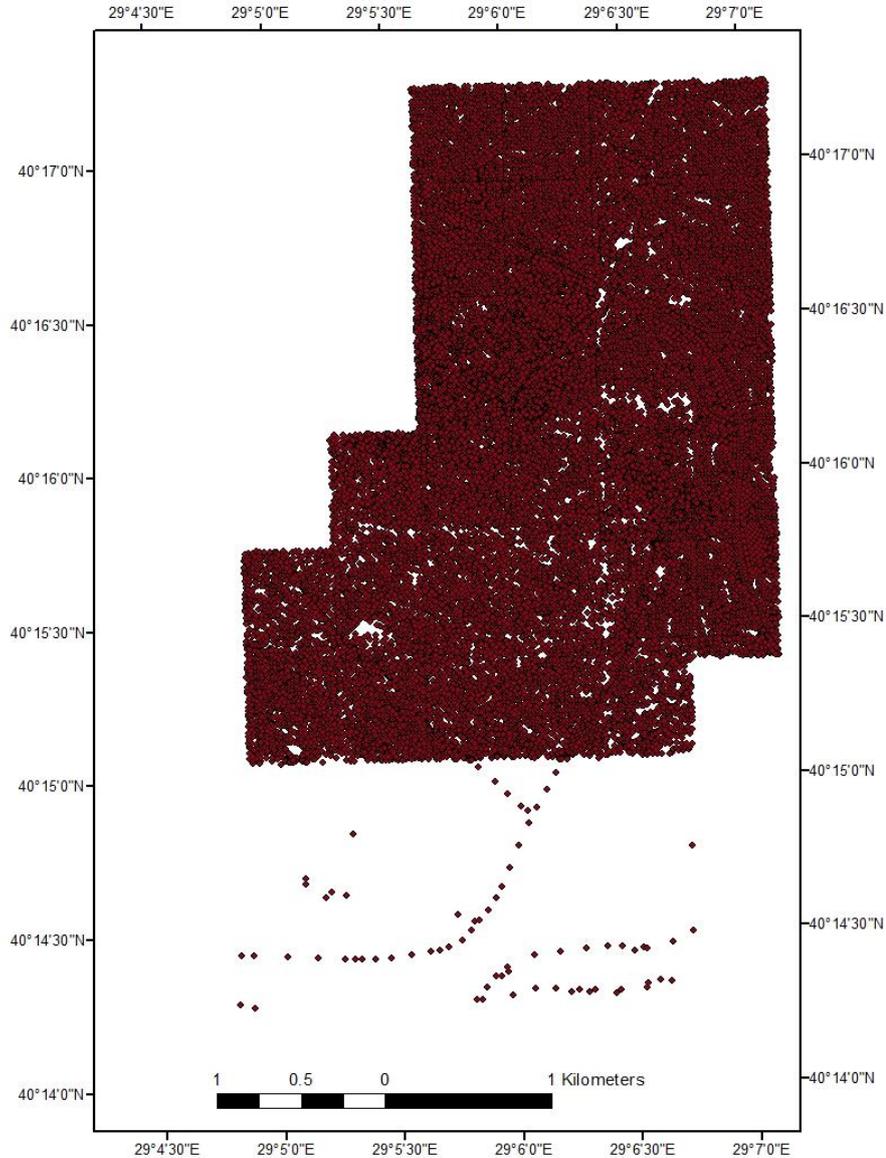
As shown in Figure 3.8, the point layer containing elevation data was converted to point shapefile in ArcMap.

**Figure 3.8.** Point elevation data of Ismetiye channel and surrounding areas

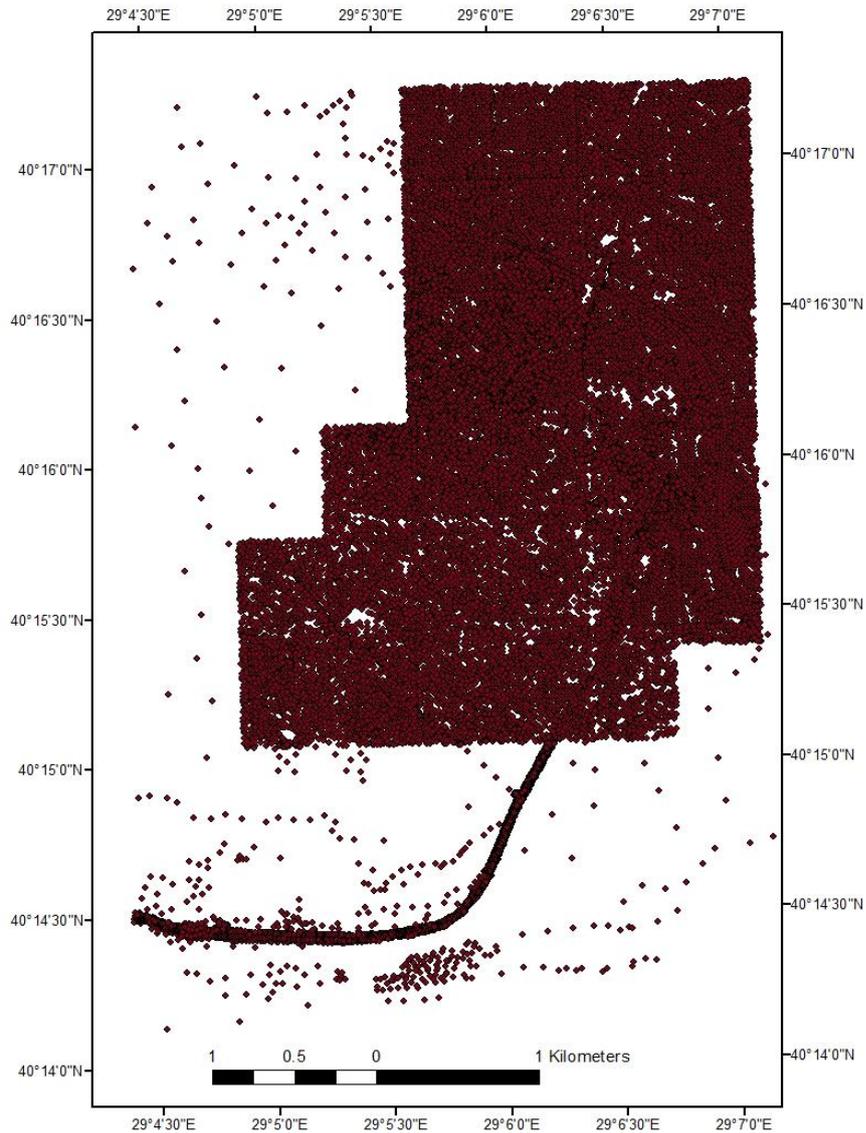
Thus, elevation data along the complete path of Ismetiye creek was obtained. This enabled us to model the complete channel until its confluence with Nilufer river. Figure 3.9 shows point elevation data of Ismetiye channel in its natural state after inserting additional elevation data.

**Figure 3.9.** Point elevation data of Ismetiye channel and surrounding areas after inserting additional points in ArcMap.

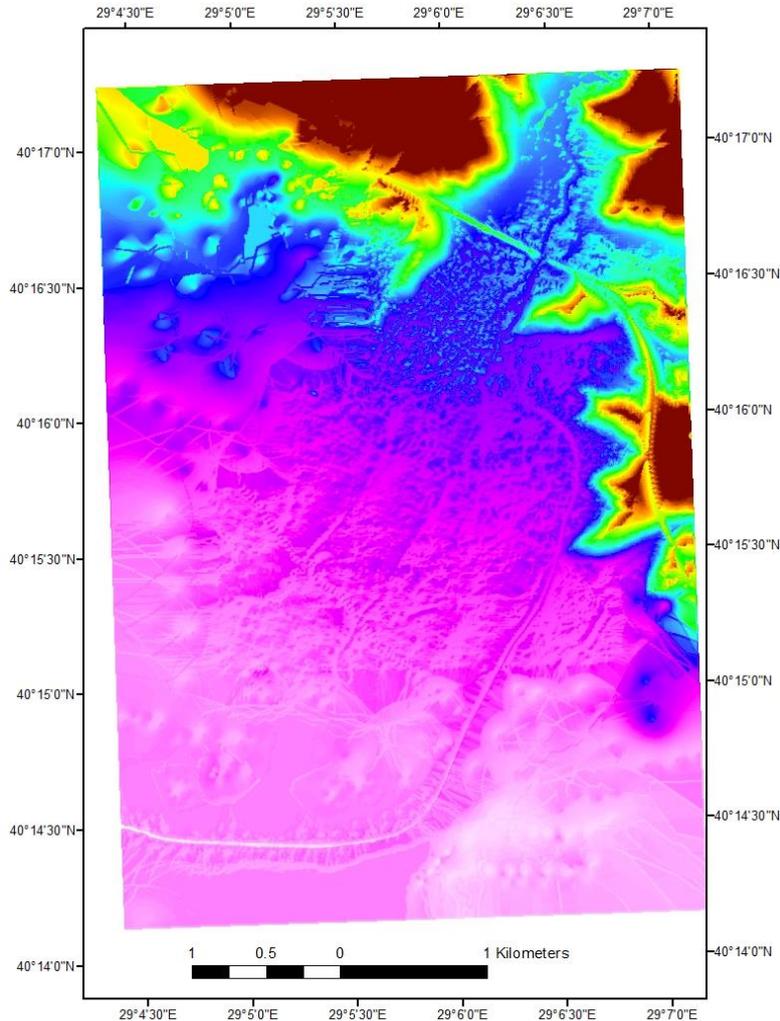
- Using Inverse Distance Weighted (IDW) raster interpolation method, a DEM was created from the above point data. The cell size used for creating DEM in this study was 0.5m. The DEM is shown in Figure 3.10.

**Figure 3.10** DEM of resolution 0.5m as obtained from IDW raster interpolation method in Arc Map

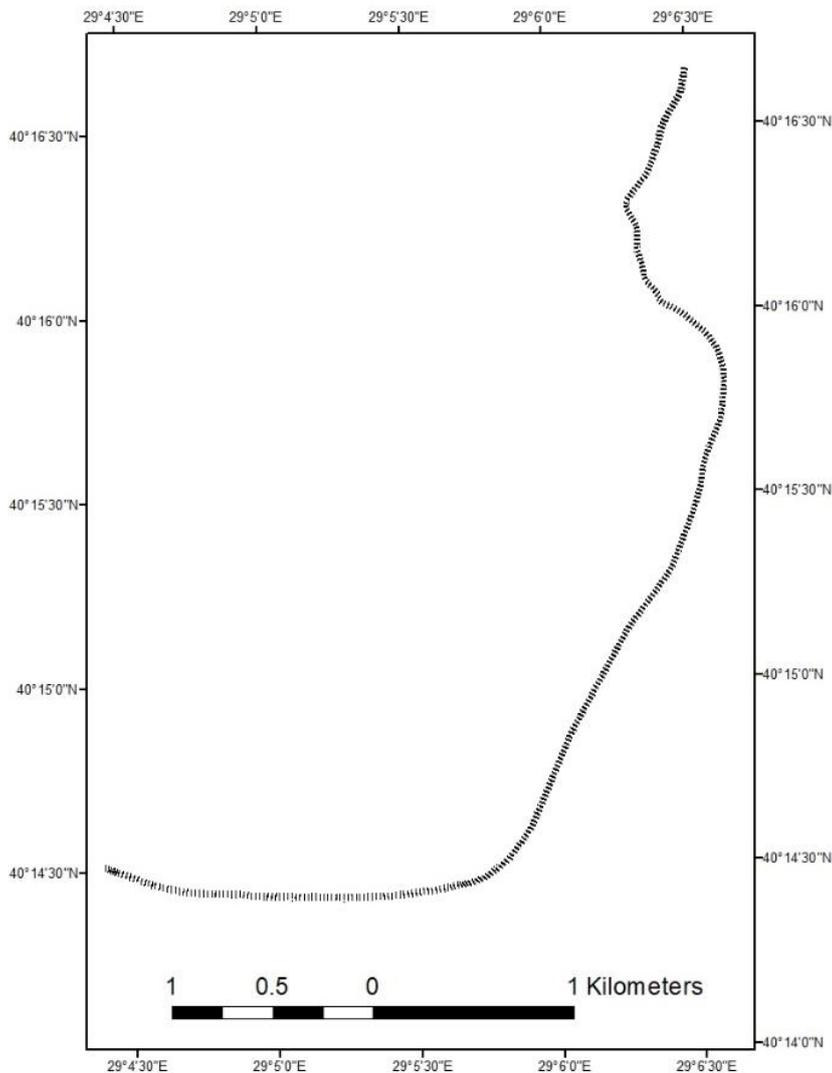
Elevation data within the concrete channel was provided in the BUSKI report (2013). This data was available with a 20-m interval for a span of 4020 m. Slope of the concrete channel was 0.008484. For the remaining downstream part of channel, assuming the same slope of the channel throughout, intermediate sections were inserted at 20-m intervals by interpolation. This was done to obtain a DEM throughout the Ismetiye channel so as to run the simulation along the path of the entire channel. Figure 3.11 shows the intermediate sections inserted in the concrete channel.

**Figure 3.11.** Intermediate sections in the concrete channel with 20-m intervals.

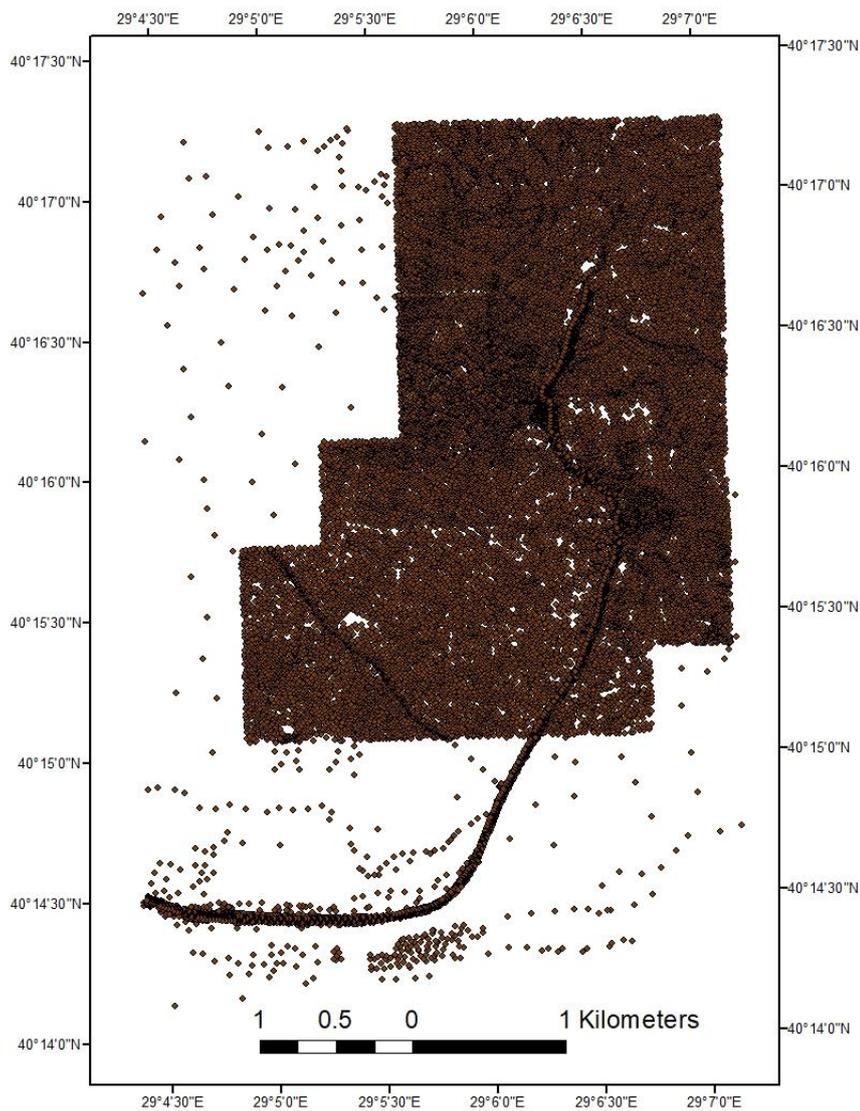
To obtain the DEM of the rehabilitated channel, the elevation data of natural channel was replaced by the elevation data of concrete channel. This was done by replacing the elevation data along the channel path by the intermediate sections as shown in the Figure 3.11 above. Figure 3.12 shows the point elevation data of Ismetiye channel in its rehabilitated state.

**Figure 3.12.** Point elevation data with concrete channel

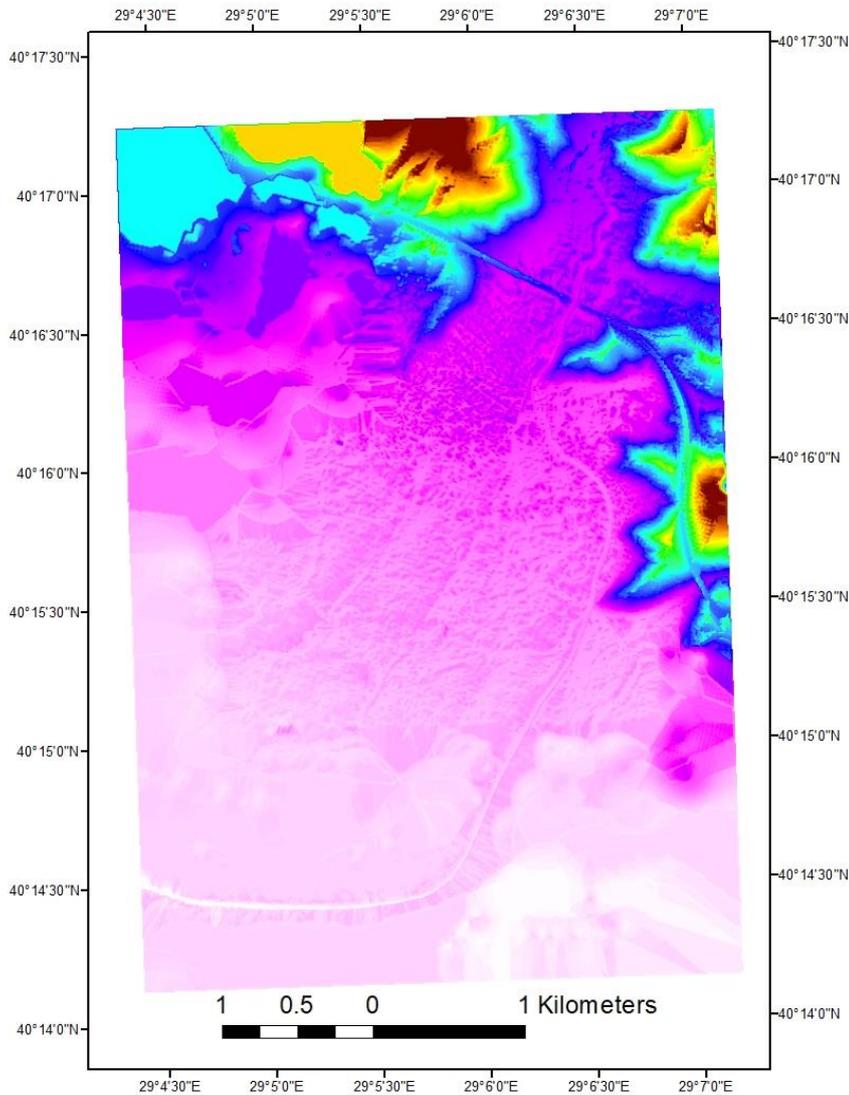
- Using Inverse Distance Weighted (IDW) raster interpolation method, a DEM with a resolution of 0.5 m was created from the above point data. Figure 3.13 shows the DEM of the rehabilitated channel.

**Figure 3.13.** DEM of the rehabilitated channel

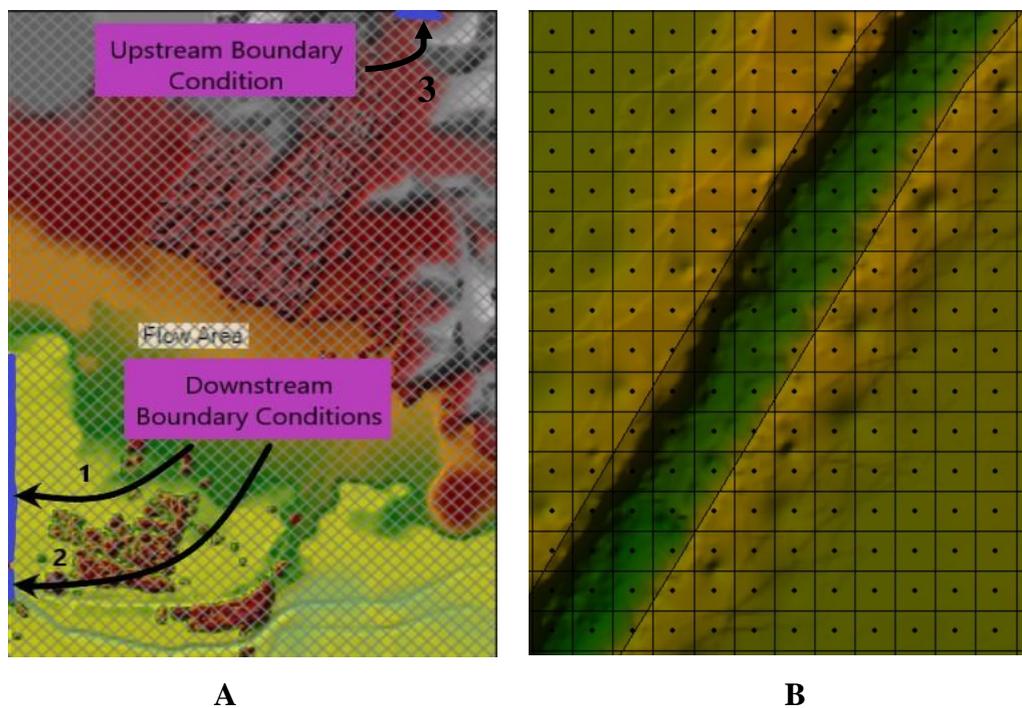
As shown in the Figure 3.20, right click on the layer 'Perimeter' and 'Edit 2D Area Properties' to define flow area and size of the mesh which was set as 10 m in our case. Figure 3.21 shows the flow area and the mesh size.

**Figure 3.21.** Flow area showing **A)** boundary conditions **B)** mesh size of 10 m

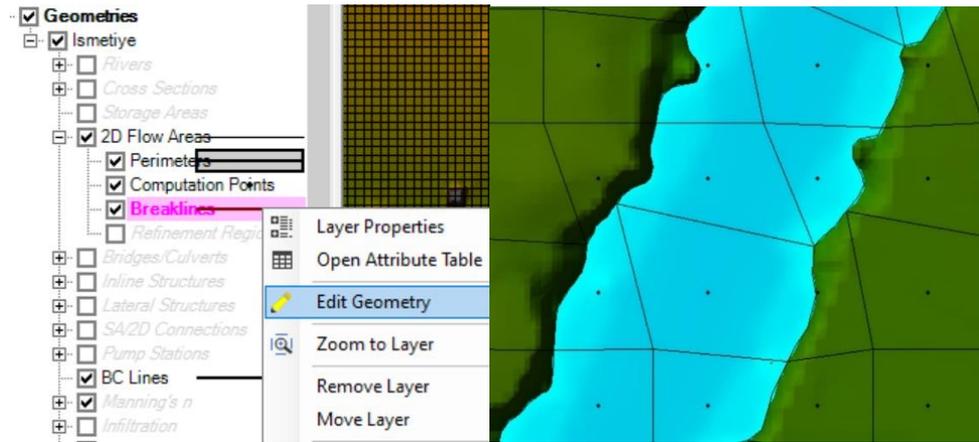
5. Under the layer '2D Flow Areas' right click on 'Breaklines' and then 'Edit Geometry', to readjust the mesh along the edges of the river by drawing lines along both edges of channel as shown in Fig 3.22.

**Figure 3.22.** Refinement of 2D mesh in RAS Mapper by using ‘breaklines’

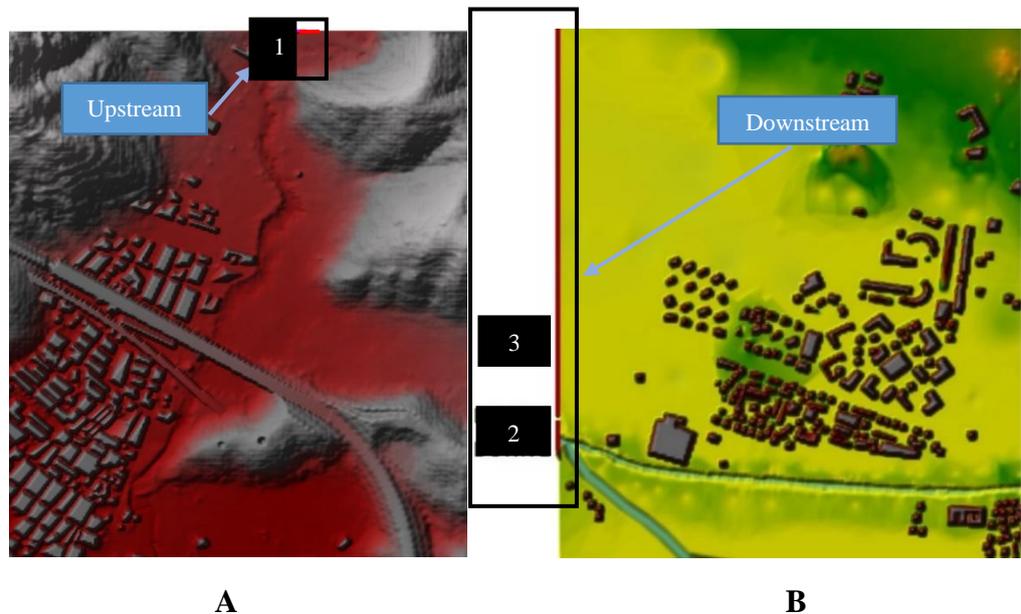
6. In order to specify the boundary conditions, under the layer ‘BC lines’, draw boundary lines at the upstream (1) and downstream (2) ends of the channel as shown in Figure 3.23. In our case, since water was accumulating towards the end of the channel rather than flowing out of the flow area, we introduced another downstream boundary condition (3) with a gentle slope of 0.001 to ensure flowing out of water from the catchment area. The values of boundary conditions are specified in step 9.

**Figure 3.23.** Magnified view of the terrain showing boundary lines on A) upstream end of the channel B) downstream end of the channel.

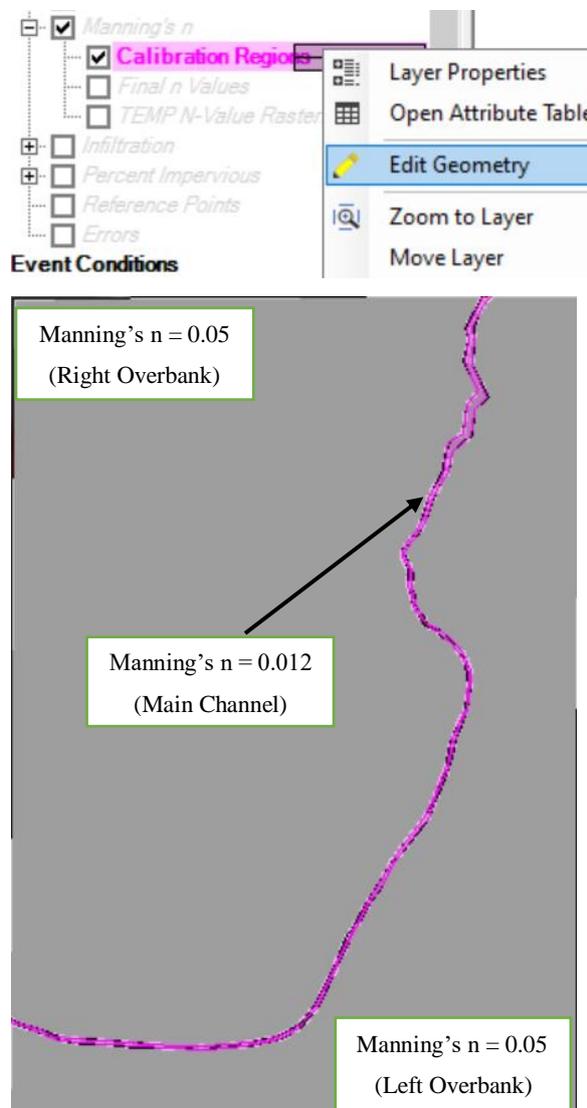
7. Assign Manning's n value to the channel by right clicking on 'Calibration Region' under 'Manning's n' layer and defining the channel geometry for which Manning's n value is to be assigned. The Manning's n value for natural channel was taken as 0.05 and for concrete channel, it was taken as 0.012 (Chow, 1959). In case of rehabilitated channel, main channel was assigned a Manning's n value of 0.012 and overbank regions were assigned a Manning's n value of 0.05. Figure 3.24 shows where to assign Manning's n value to the channel. Also, polygons drawn in case of rehabilitated channel are shown along with their Manning's n values.

**Figure 3.24.** Assigning Manning's n value to the concrete channel and overbanks

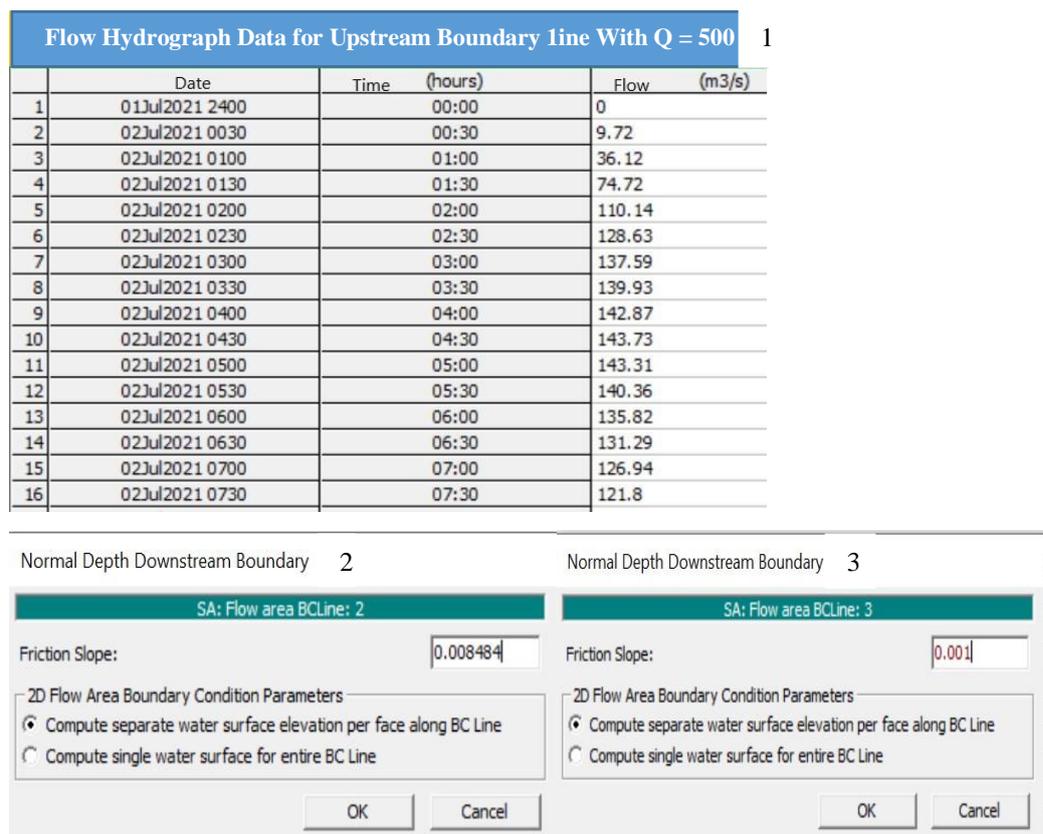
- In the 'view/edit unsteady flow data' section, add the boundary conditions; flow hydrograph for upstream (given in Table 3.2) and friction slope for downstream are specified as depicted in the Figure 3.26.

**Figure 3.26.** Adding flow hydrograph and friction slope to boundary conditions

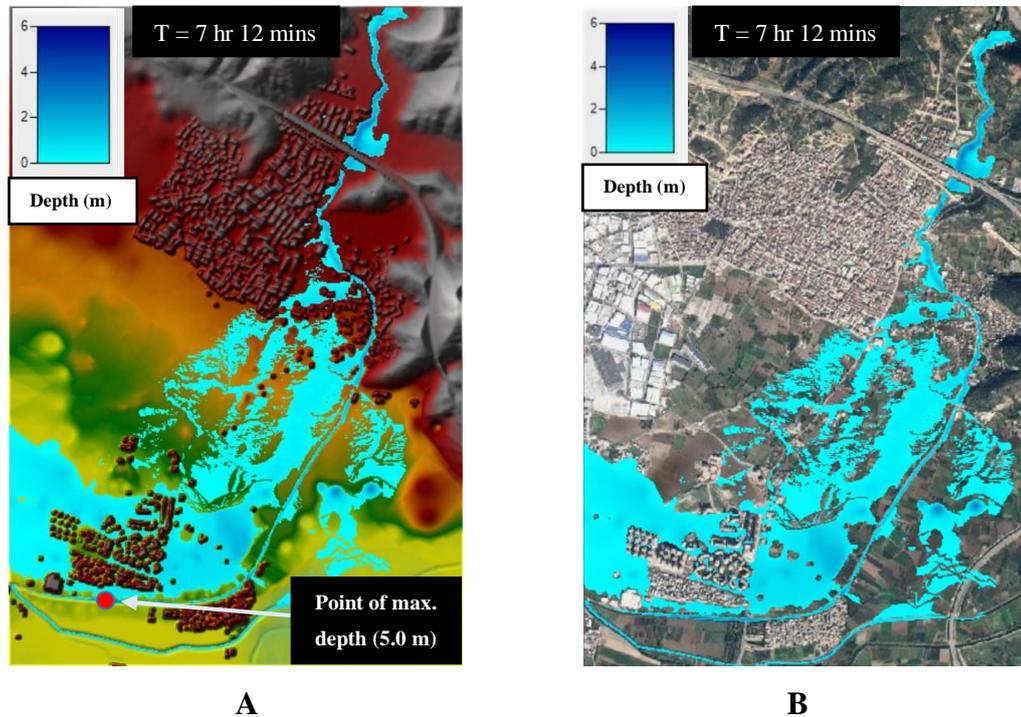
There was a significant flooding throughout the catchment area of Ismetiye creek as shown in Figure 4.1 and Figure 4.2. In the case of  $Q_{500}$ , the time of maximum extent is 7 hours 12 minutes and the maximum depth is 5.0 m as shown in Figure 4.1.

**Figure 4.1.** Case 1: Flood map for  $Q_{500}$  before rehabilitation A) HEC-RAS terrain view B) Google satellite view

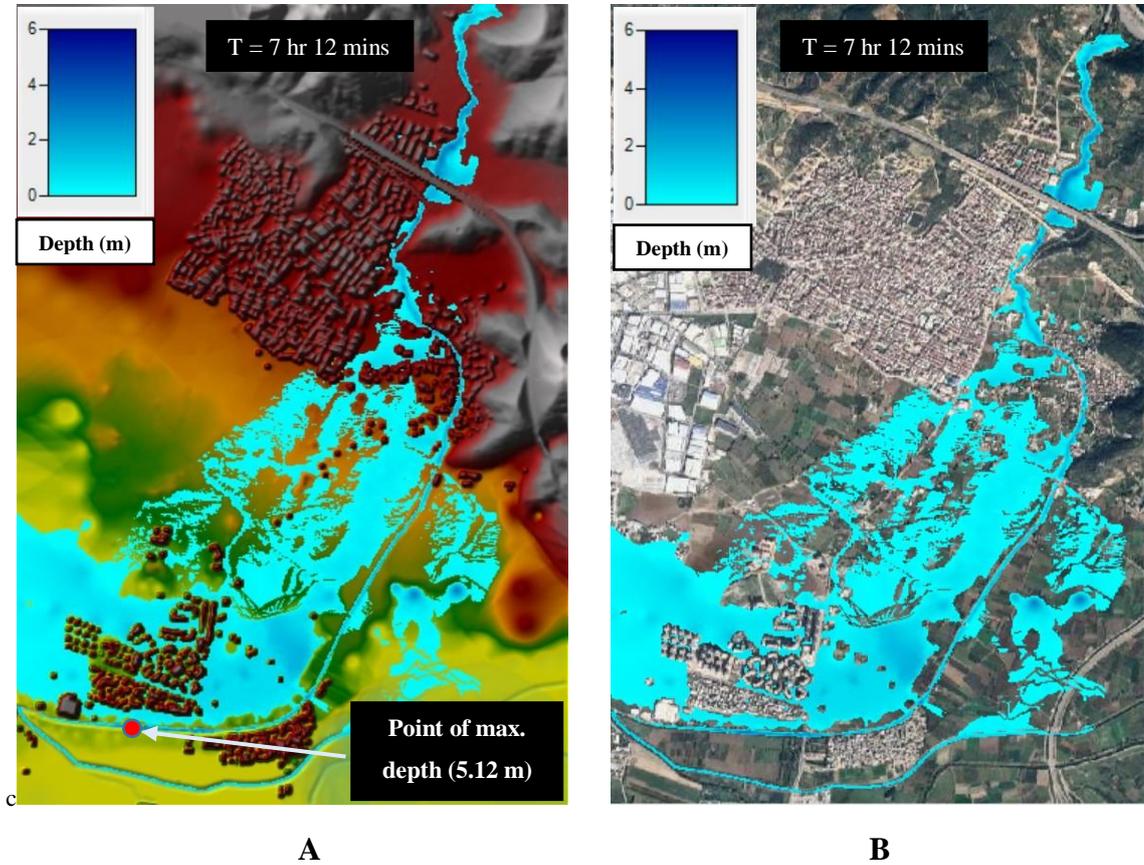
For  $Q_{1000}$ , the time of maximum extent for is 7 hour 12 minutes and the maximum depth is 5.12 m.

**Figure 4.2.** Case 2: Flood map for  $Q_{1000}$  before rehabilitation A) HEC-RAS terrain view B) Google satellite view

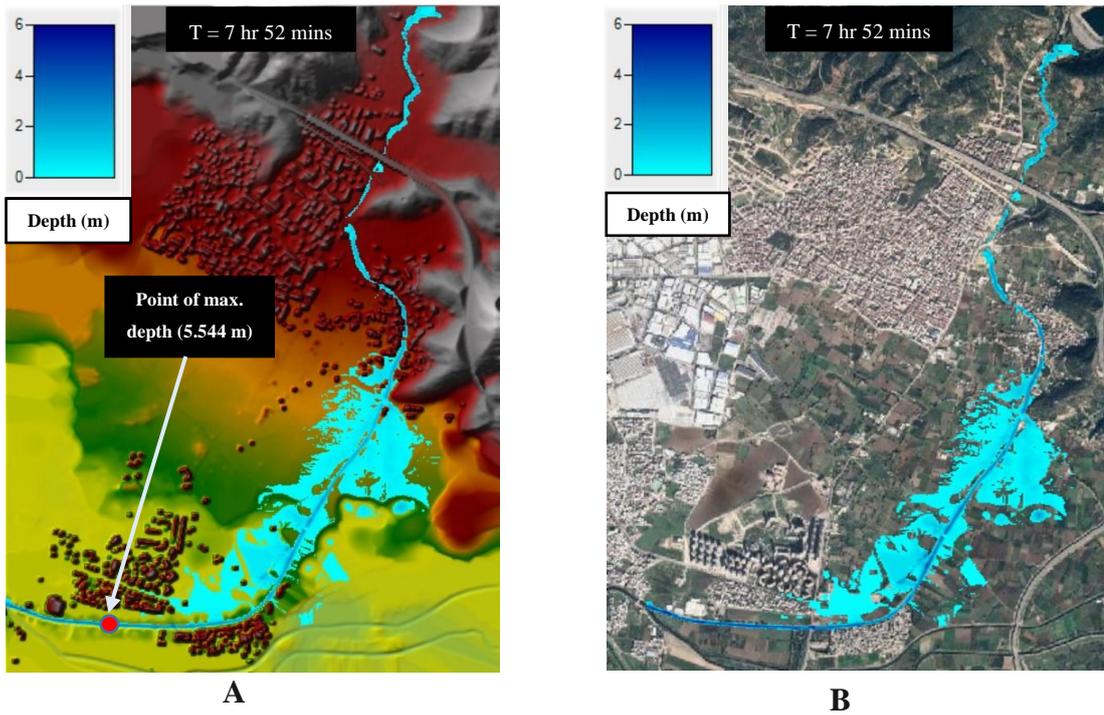
In the case of simulation after rehabilitation of Ismetiye Creek, it was found that flooding decreased significantly as compared to the case of natural channel. Figure 4.3 and Figure 4.4 show the flood maps after rehabilitation for  $Q_{500}$  and  $Q_{1000}$  respectively. For  $Q_{500}$ , the time of maximum extent is 7 hour 52 minutes and the maximum depth is 5.544 m. For  $Q_{1000}$ , the time of maximum extent is 7 hour 52 minutes and the maximum depth is 5.794 m.

**Figure 4.3.** Case 3: Flood map for  $Q_{500}$  after rehabilitation A) HEC-RAS terrain view B) Google satellite view

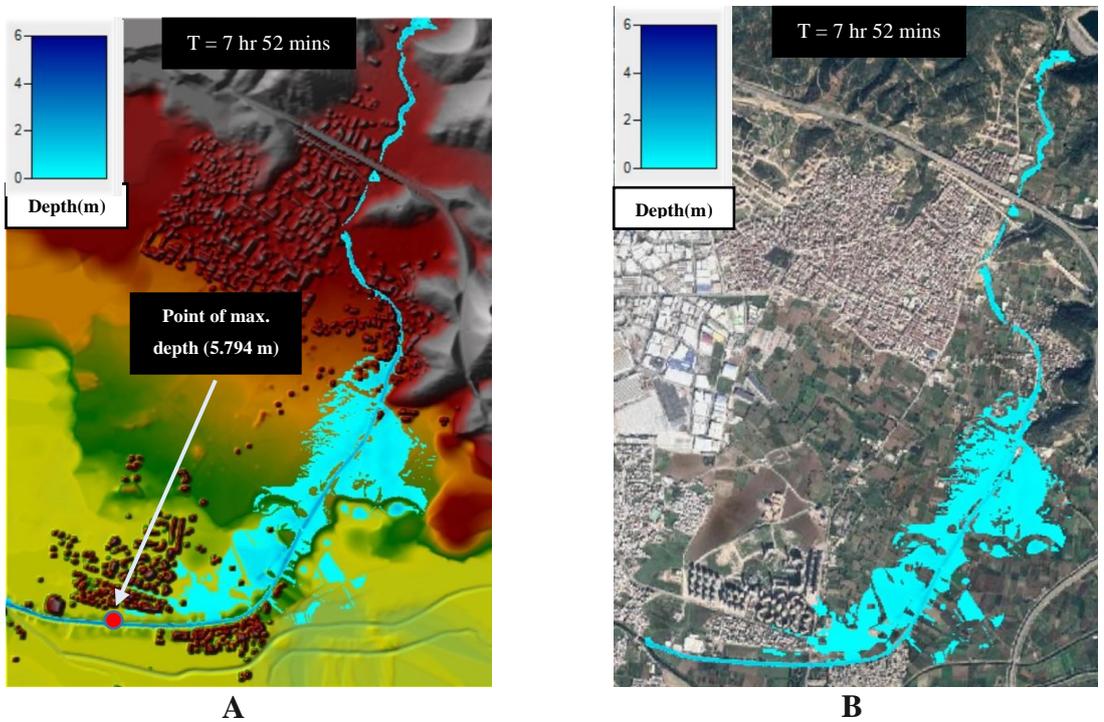
**Figure 4.4.** Case 4: Flood map for  $Q_{1000}$  after rehabilitation A) HEC-RAS terrain view B) Google satellite view

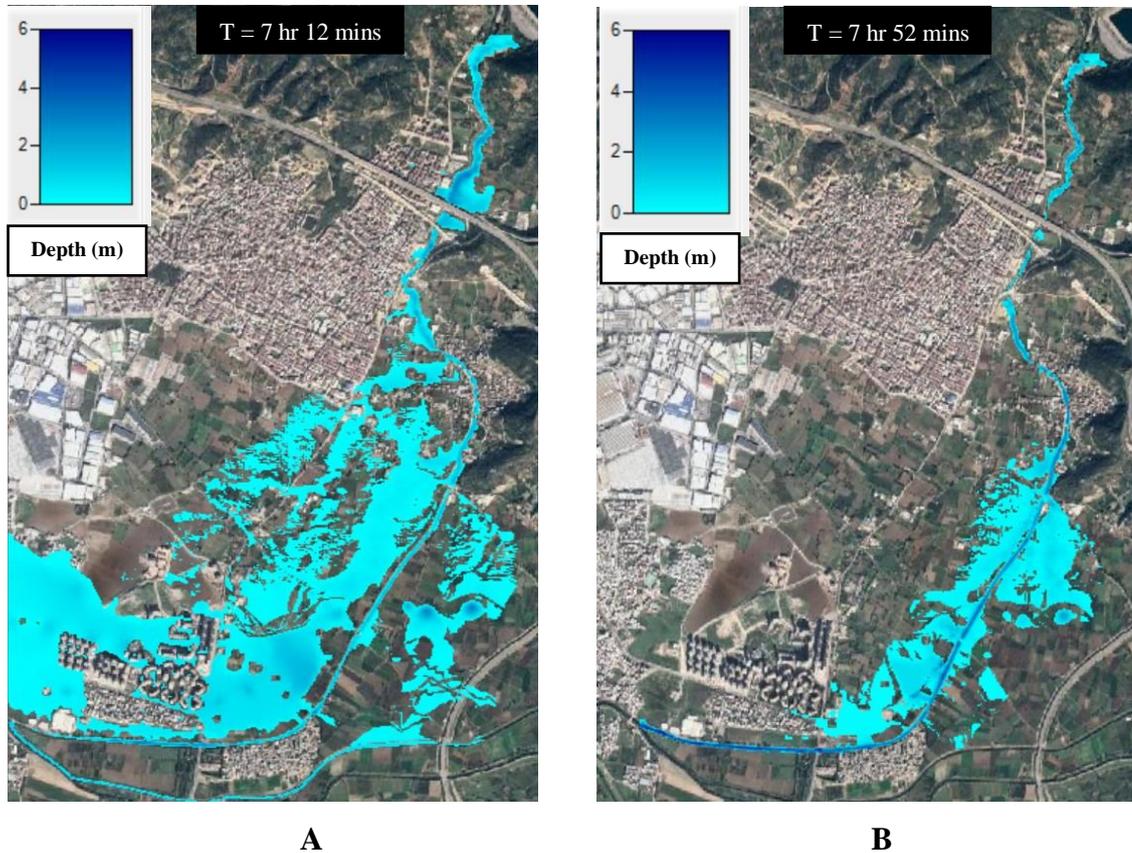
**Figure 4.5.** The comparison of flood maps for  $Q_{500}$  **A)** before rehabilitation **B)** after rehabilitation

Before rehabilitation, the extent of flooding was more at the beginning of the channel. As we go downstream, there was overbank flow observed which resulted in the flooding of catchment area. The overbank flow also flooded the dry channel present in the south of the Ismetiye creek. Moreover, new settlement region located on the right overbank side of downstream end of the channel also observed flooding.

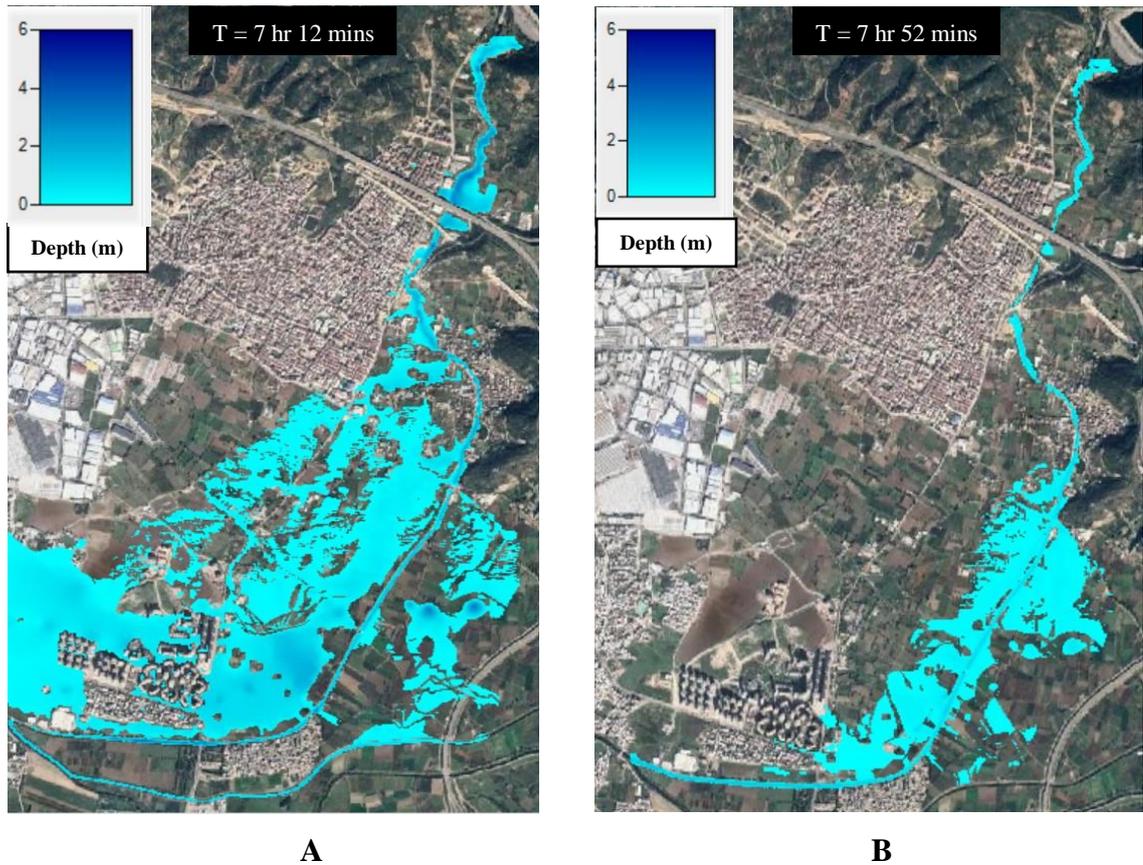
**Figure 4.6.** The comparison of flood maps for  $Q_{1000}$  **A)** before rehabilitation **B)** after rehabilitation

As expected, the extent of flooding observed for  $Q_{1000}$  was more than that of  $Q_{500}$ . The maximum depth observed in case of  $Q_{1000}$  was also higher as compared to that of  $Q_{500}$ . Before rehabilitation, maximum depth for  $Q_{500}$  was 5.0 m while for  $Q_{1000}$ , it was 5.12 m. On the other hand, after rehabilitation, maximum depth in case of  $Q_{500}$  was 5.544 m while for  $Q_{1000}$ , it was 5.794 m. Clearly, the maximum depths were higher after rehabilitation because of the fact that more water was retained in the main channel.
