**THE IMPACT OF RIVER REHABILITATION ON  
FLOOD MITIGATION:  
A CASE STUDY OF ISMETIYE CREEK BURSA**

YÜKSEK LİSANS TEZİ  
İNŞAAT MÜHENDİSLİĞİ ANABİLİM DALI

BURSA – 2022  
**Her Hakkı Saklıdır**

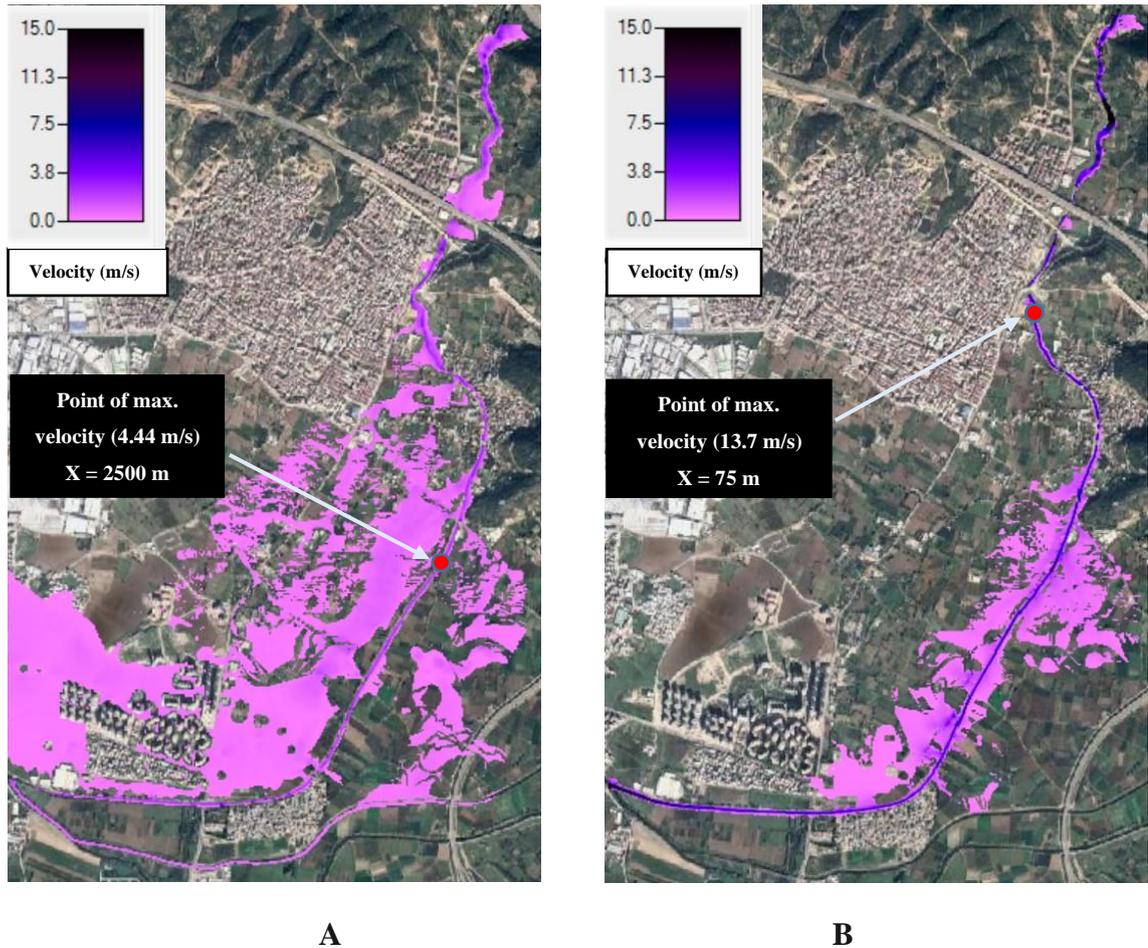
**Figure 4.7.** Velocity maps for  $Q_{500}$  **A)** before rehabilitation **B)** after rehabilitation

Before rehabilitation, a maximum velocity of 4.44 m/s was observed at  $X = 2500$  m in the main channel. High velocity of flow in a natural river bed would result in erosion of soil and deformation of the bed. After rehabilitation, a maximum velocity of 13.7 m/s at  $X = 75$  m was observed in the main channel. Thus, the velocity of flow in the main channel was much less before rehabilitation as compared to the case of after rehabilitation. This was observed due to the fact that the main channel before rehabilitation retained less water with high overflow. However, for the overbanks, velocity was observed to be higher before rehabilitation and lower after rehabilitation. This can also be attributed to the fact that there was high overflow before rehabilitation. Hence, it can be said that not only did the rehabilitation of channel decrease the overflow but also the decrease in velocity of overflow after rehabilitation reduced the risk of soil erosion near the banks.

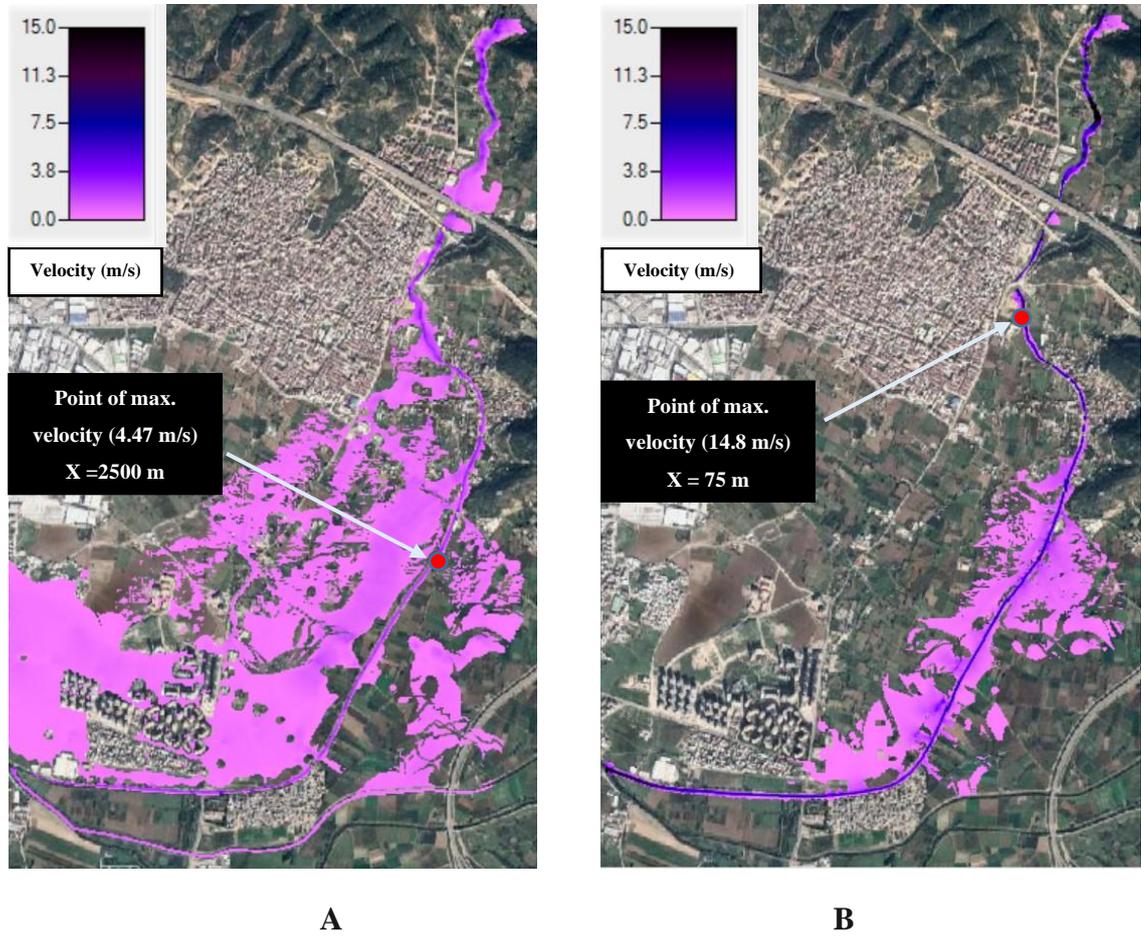
**Figure 4.8.** Velocity maps for  $Q_{1000}$  **A)** before rehabilitation **B)** after rehabilitation

Maximum velocity of 4.47 m/s was observed at  $X = 2500$  m in the main channel before rehabilitation. After rehabilitation, a maximum velocity of 14.8 m/s was observed at  $X = 75$  m. As compared to the maximum velocities obtained in the case of  $Q_{500}$ , the maximum velocities in the case of  $Q_{1000}$  were marginally higher. However, the locations of points of maximum velocities remained the same as that of  $Q_{500}$ .

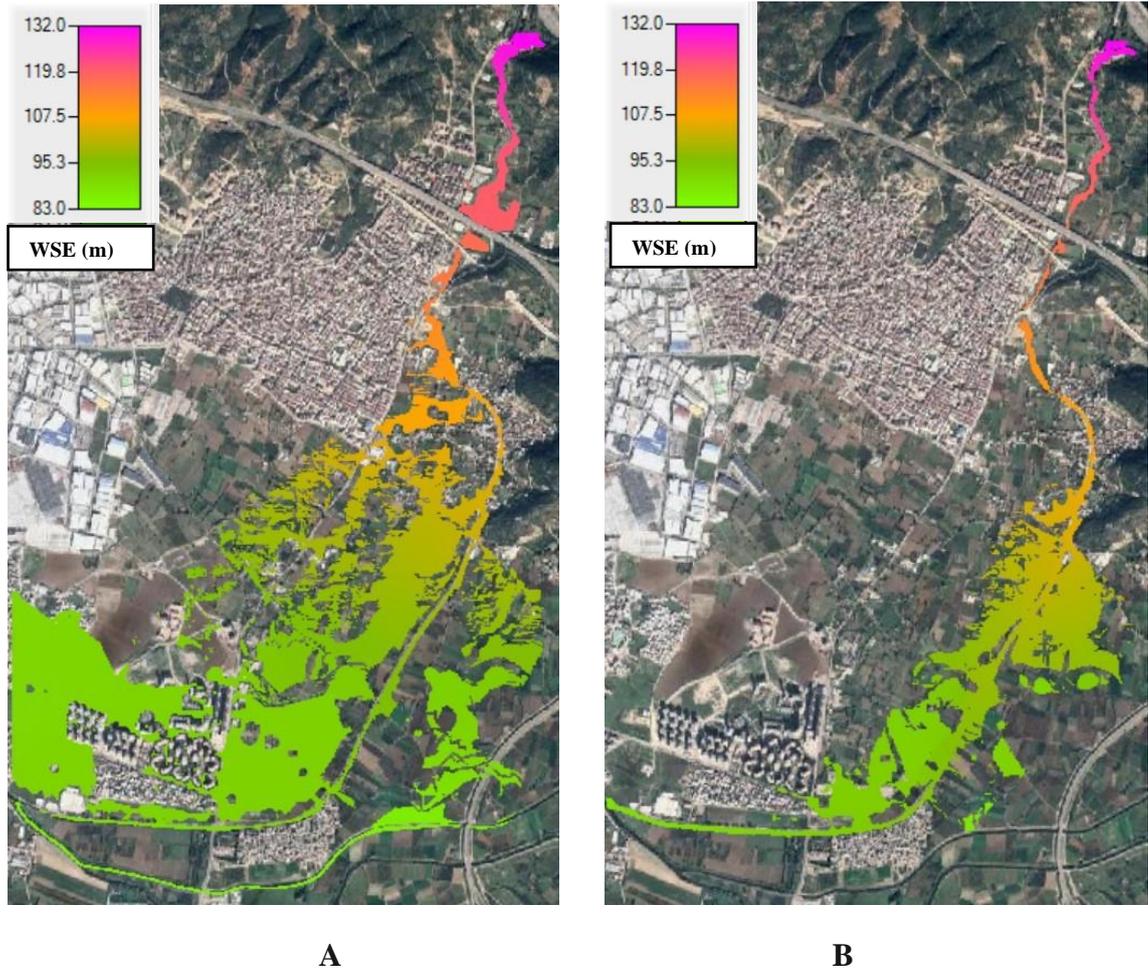
Figure 4.9 shows the comparison of water surface elevation (WSE) before and after rehabilitation of Ismetiye Creek for  $Q_{500}$ .

**Figure 4.9.** Water Surface Elevation maps for  $Q_{500}$  **A)** before rehabilitation **B)** after rehabilitation

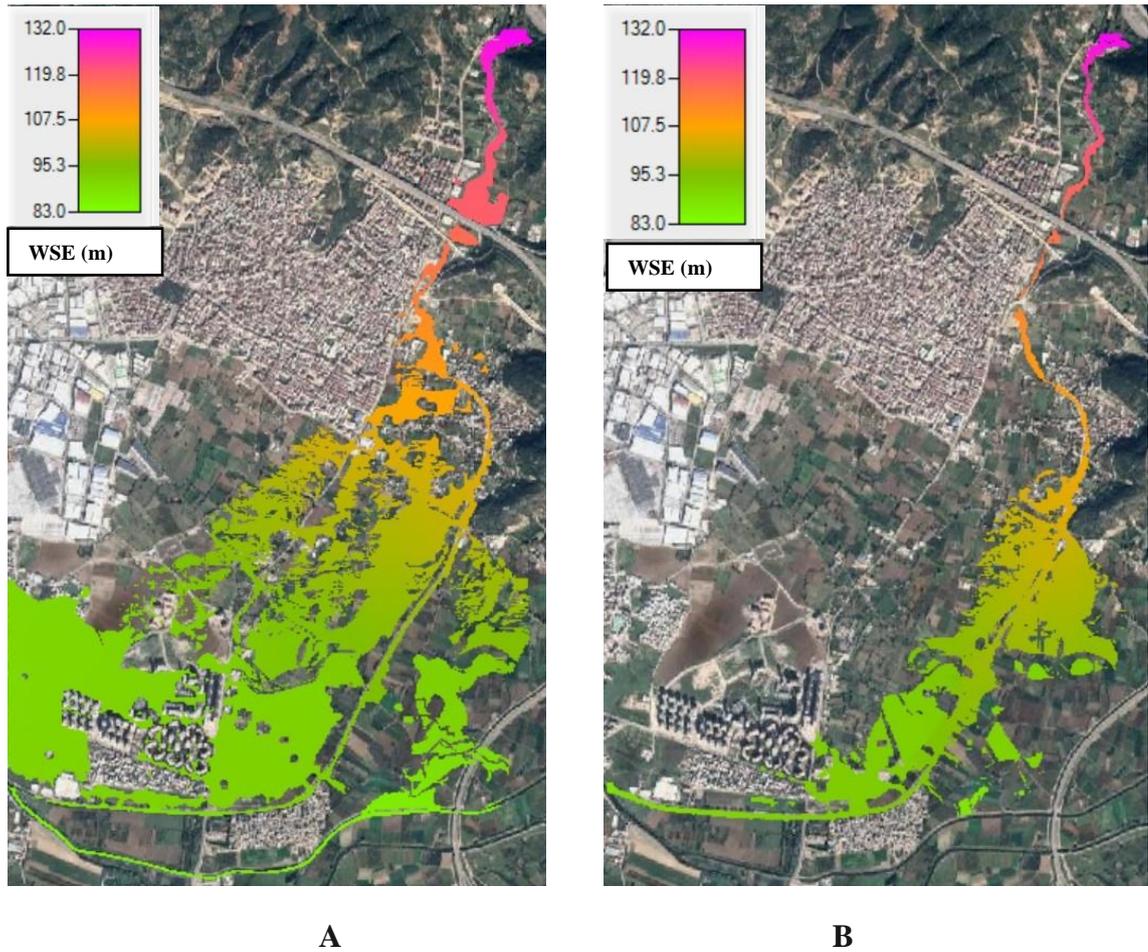
Figure 4.10 shows the comparison of water surface elevation (WSE) before and after rehabilitation of Ismetiye Creek for  $Q_{1000}$ .

**Figure 4.10.** Water Surface Elevation maps for  $Q_{1000}$  **A)** before rehabilitation **B)** after rehabilitation

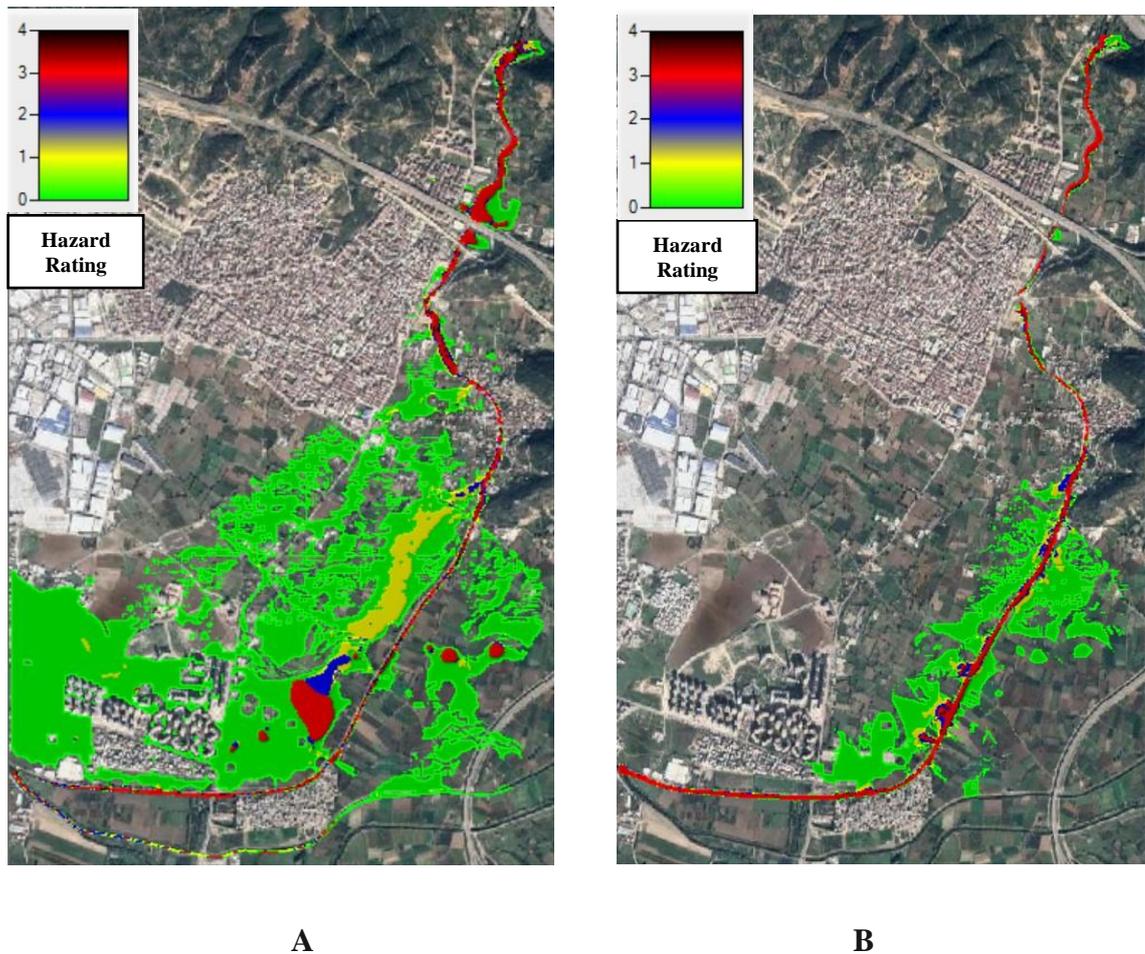
Figure 4.11 shows the comparison of flood hazard zones before and after rehabilitation of Ismetiye creek for Q<sub>500</sub>.

**Figure 4.11.** Flood hazard zones for Q<sub>500</sub> **A)** before rehabilitation **B)** after rehabilitation

Flood hazard maps were created to compare the risk of floods before and after the rehabilitation of Ismetiye creek. Flood risk zones as per the guidelines of Federal Emergency Management Agency (FEMA) 2018 were defined as shown in Table. 4.1. The magnitude of flood hazard is calculated by Eq. (4.1) (FEMA 2018).

Hazard zones were assigned a hazard rating starting from 0 to 4 with 0 corresponding to very low risk zone and 4 corresponding to extreme risk zone.

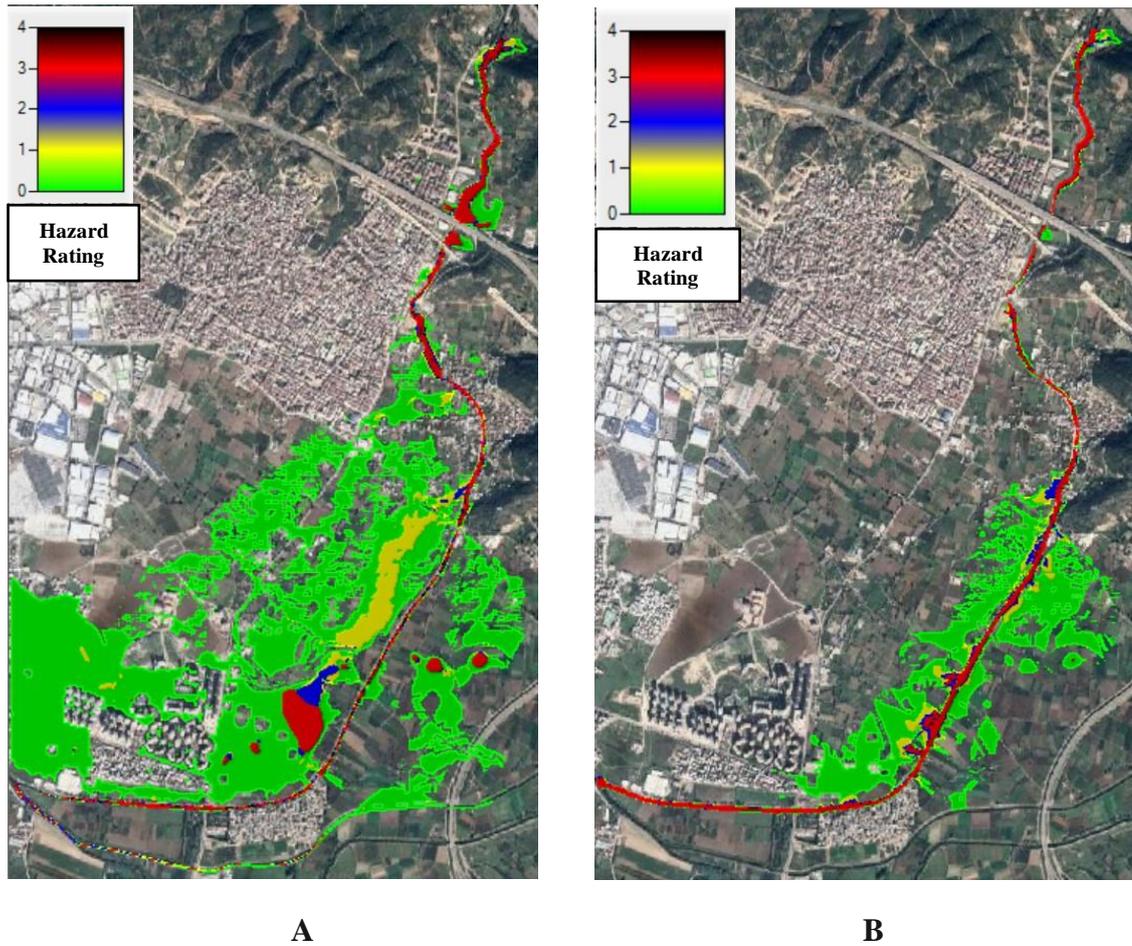
Figure 4.12 shows the comparison of flood hazard zones before and after rehabilitation of Ismetiye creek for  $Q_{1000}$ .

**Figure 4.12.** Flood hazard zones for  $Q_{1000}$  **A)** before rehabilitation **B)** after rehabilitation

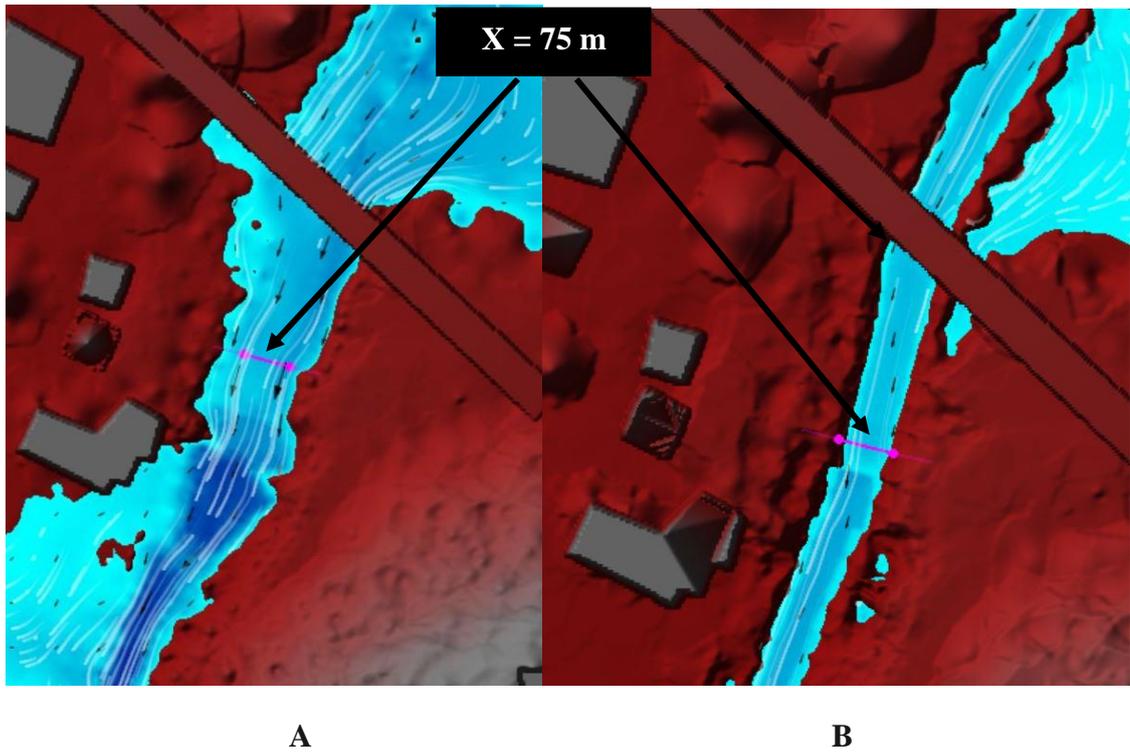
Cross-sectional lines were drawn at  $X= 75 \text{ m}$ ,  $1500 \text{ m}$ ,  $3000 \text{ m}$  and  $4000 \text{ m}$  along the channel in order to obtain flow hydrographs for  $Q_{500}$  and  $Q_{1000}$ . Separate lines were drawn for the main channel (MC) and each overbank. Therefore, hydrographs for the MC, right overbank (ROB) and left overbank (LOB) were calculated separately for each cross-section. Figure 4.13 shows the cross-section at  $X= 75 \text{ m}$  for  $Q_{1000}$ .

**Figure 4.13.** Cross-sections at  $X=75 \text{ m}$  for  $Q_{1000}$  **A)** before rehabilitation **B)** after rehabilitation

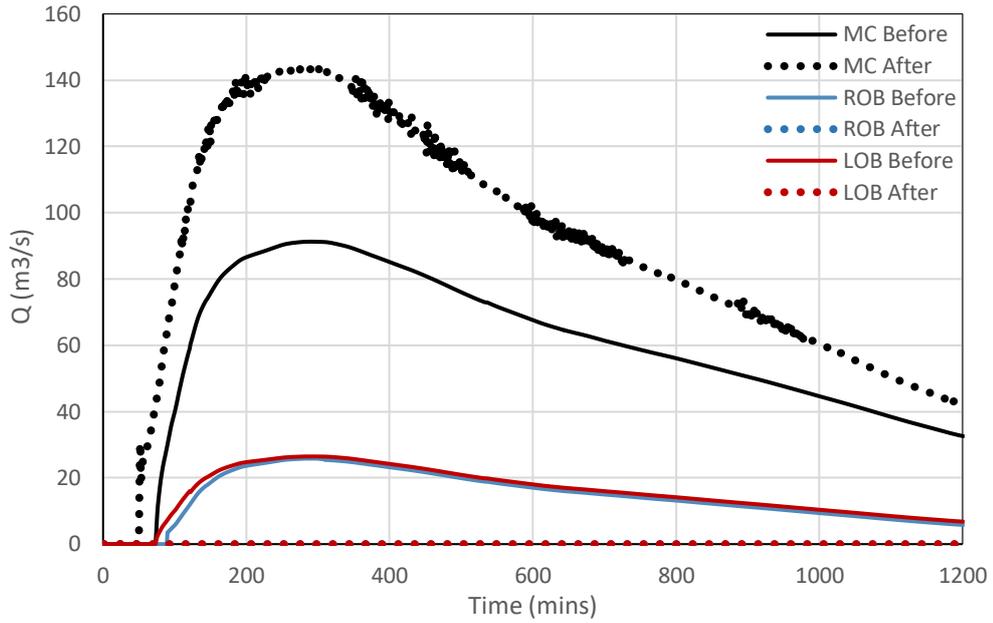
**Figure 4.14.** Flow hydrographs for  $Q_{500}$  at  $X=75$  m for main channel and overbanks

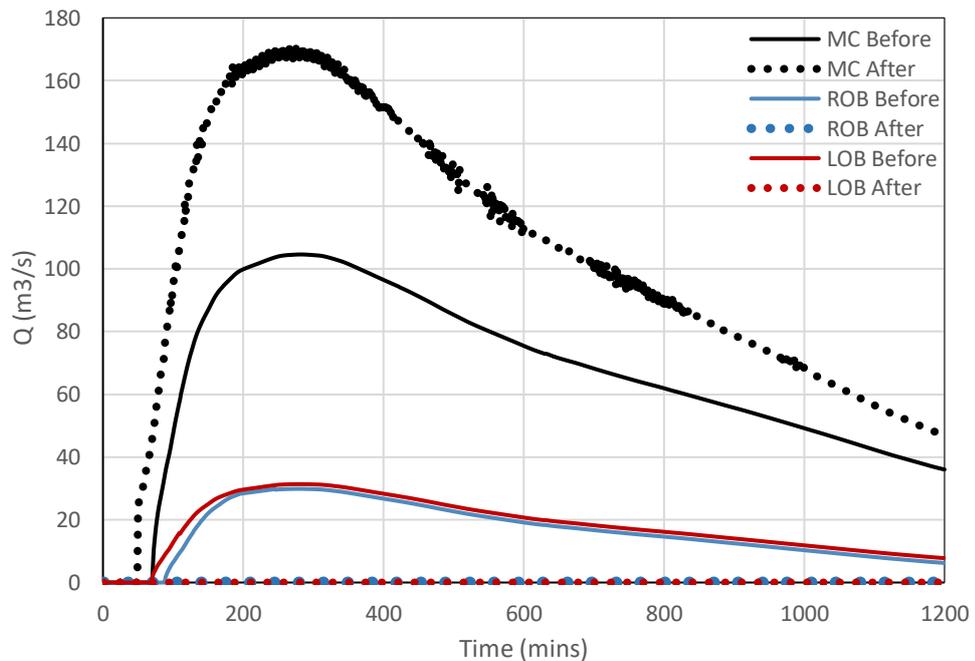
**Figure 4.15.** Flow hydrographs for  $Q_{1000}$  at  $X=75$  m for main channel and overbanks

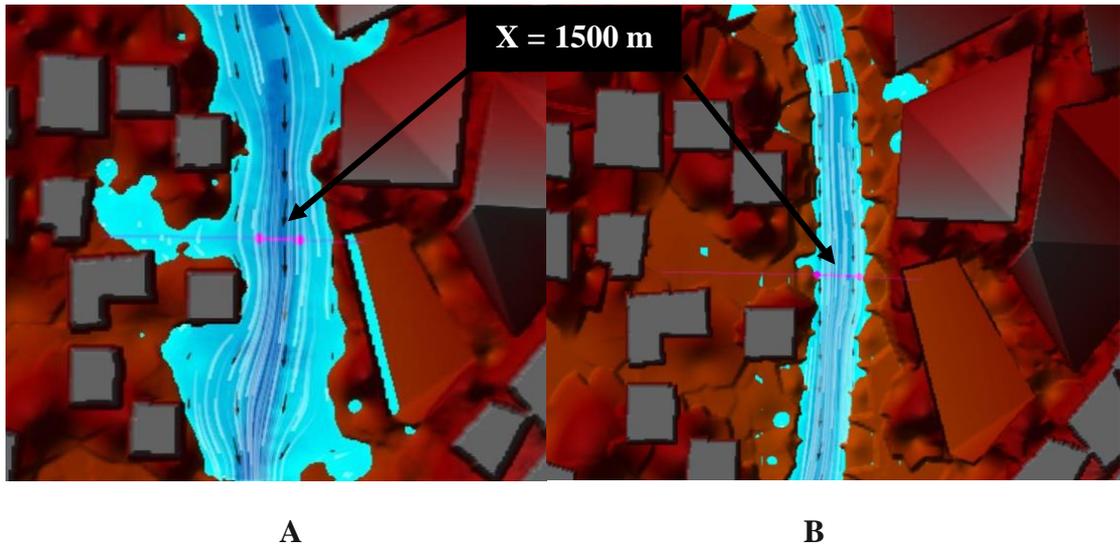
**Figure 4.16.** Cross-sections at  $X=1500 \text{ m}$  for  $Q_{1000}$  **A)** before rehabilitation **B)** after rehabilitation

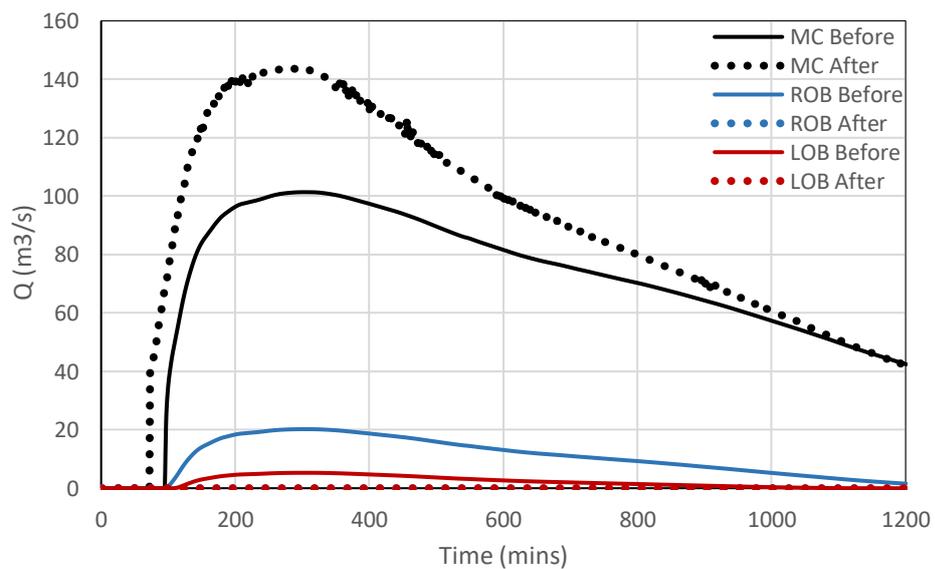
**Figure 4.17.** Flow hydrographs for  $Q_{500}$  at  $X=1500 \text{ m}$  for main channel and overbanks

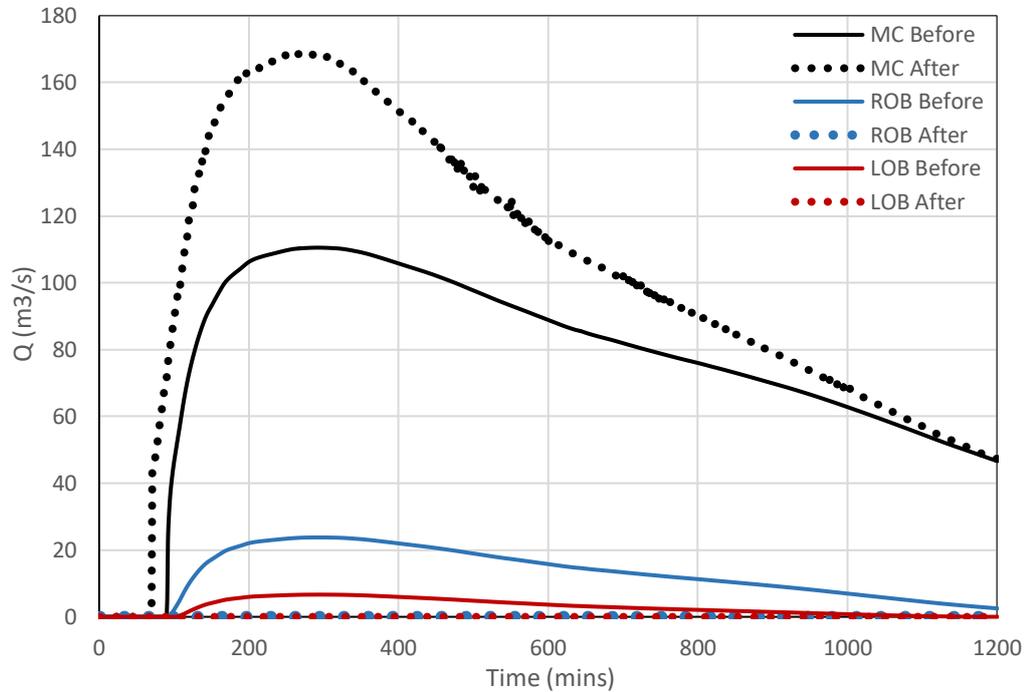
**Figure 4.18.** Flow hydrographs for  $Q_{1000}$  at  $X=1500 \text{ m}$  for main channel and overbanks

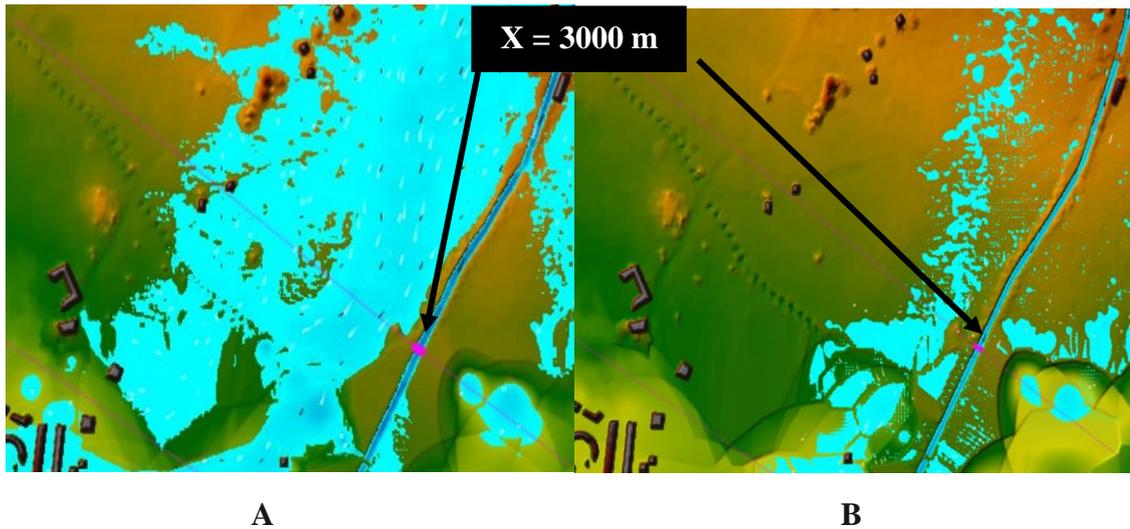
**Figure 4.19.** Cross-sections at X= 3000 m for  $Q_{1000}$  A) before rehabilitation B) after rehabilitation

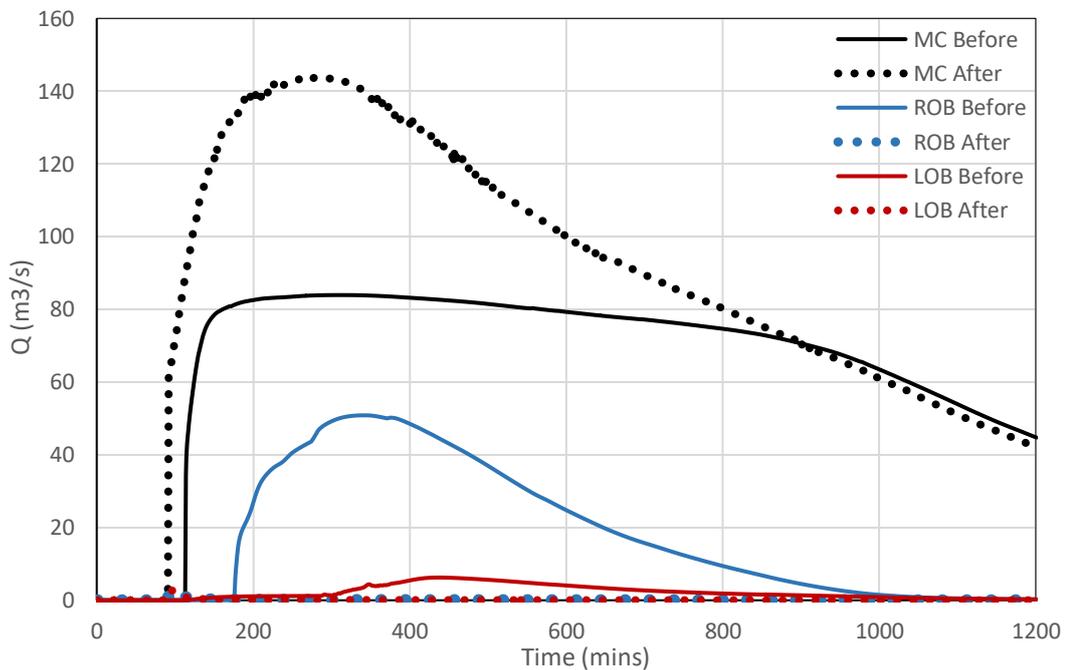
**Figure 4.20.** Flow hydrographs for  $Q_{500}$  at X=3000 m for main channel and overbanks

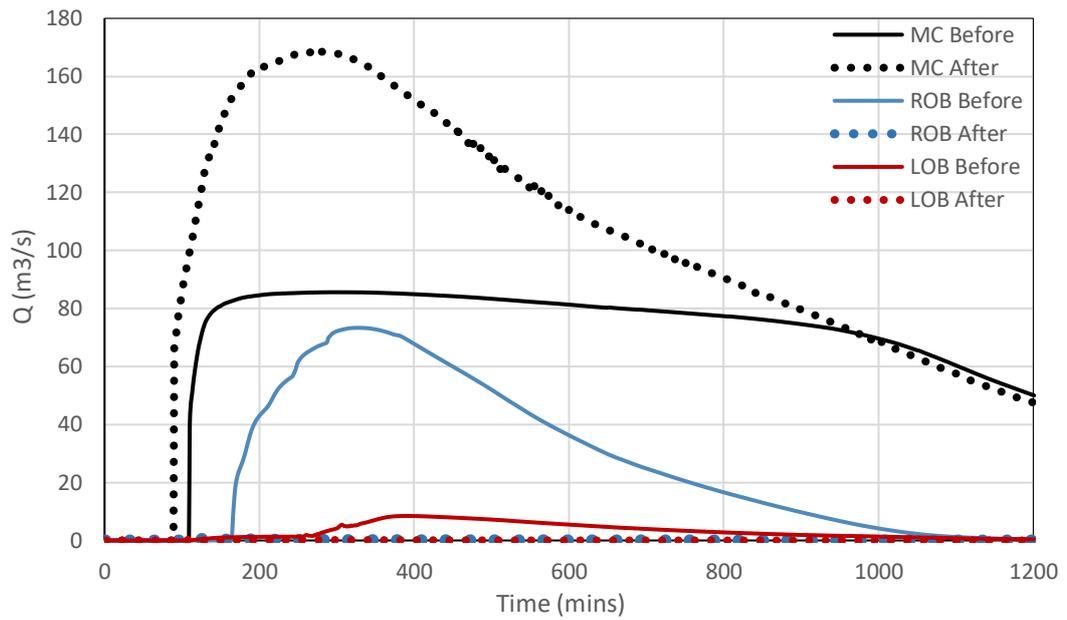
**Figure 4.21.** Flow hydrographs for  $Q_{1000}$  at  $X=3000$  m for main channel and overbanks

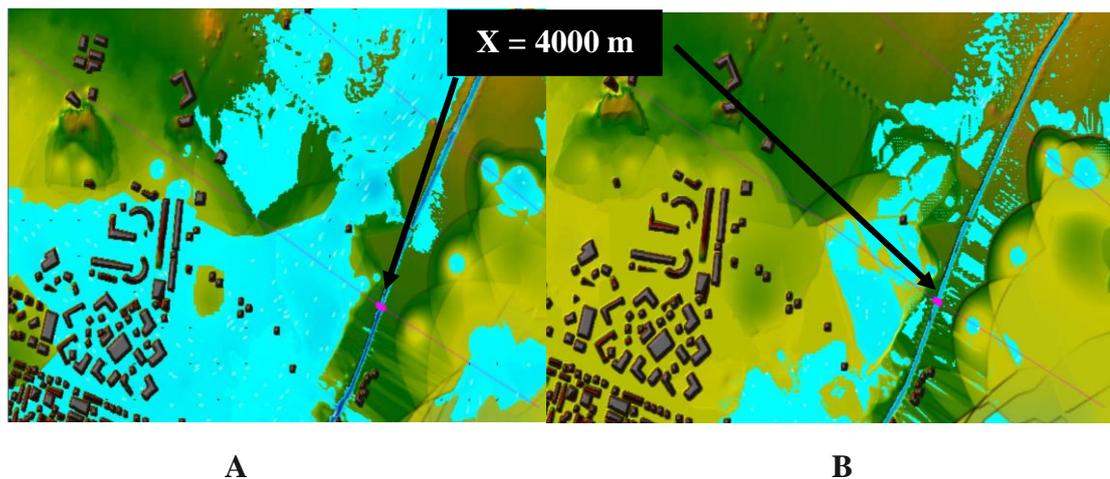
**Figure 4.22.** Cross-sections at  $X=4000$  m for  $Q_{1000}$  **A)** before rehabilitation **B)** after rehabilitation

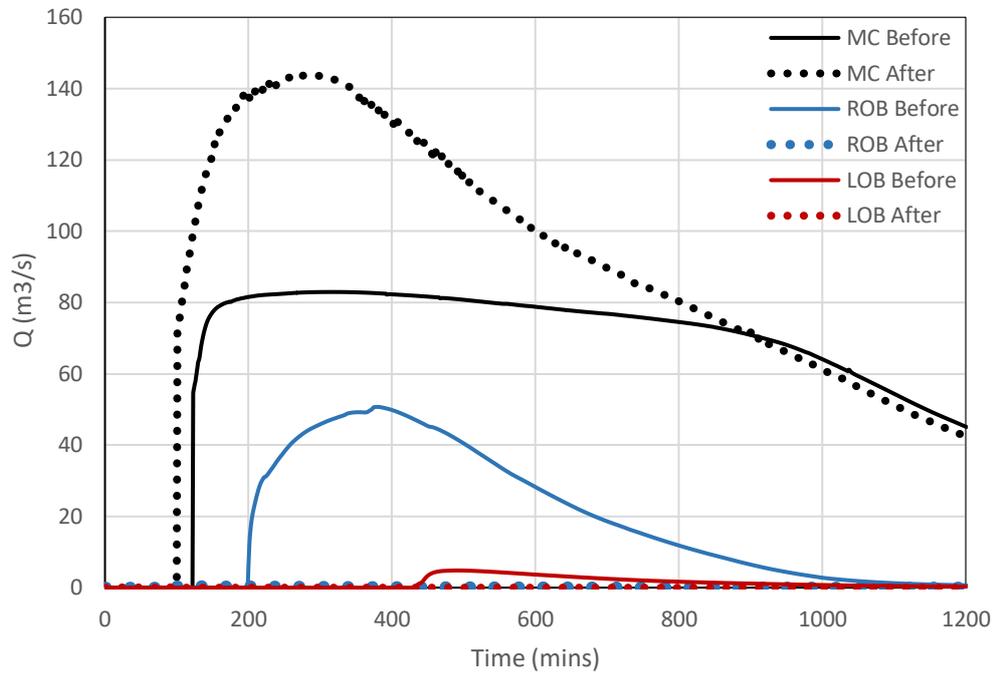
**Figure 4.23.** Flow hydrographs for  $Q_{500}$  at  $X=4000 \text{ m}$  for main channel and overbanks

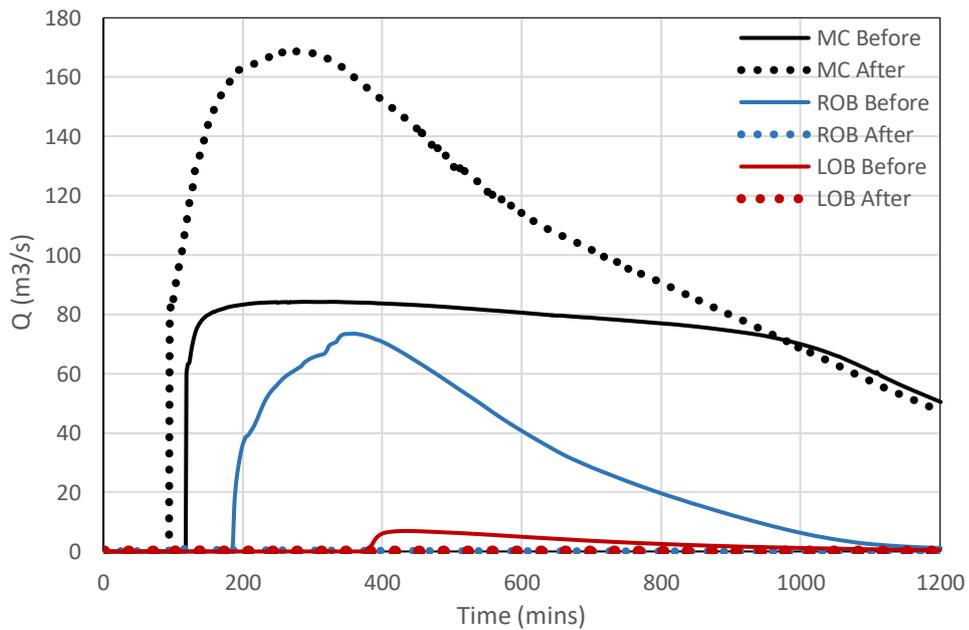
**Figure 4.24.** Flow hydrographs for  $Q_{1000}$  at  $X=4000 \text{ m}$  for main channel and overbanks
