Research Article

The Dynamic Properties of Historic Timber-Framed Masonry Structures in Bursa, Turkey

Uludağ University, Architecture Faculty, 16059 Bursa, Turkey

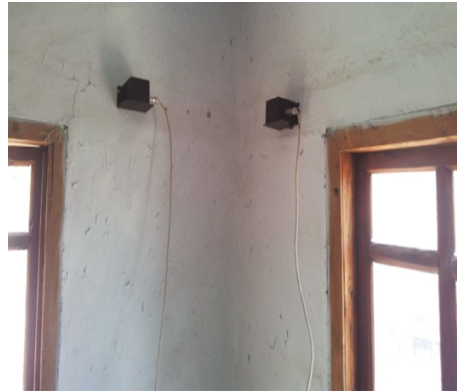
FIGURE 6: The sensor placements.

The modal analysis tests are performed on six timber houses in Görükle and Ürünlü villages in Bursa City. Studied houses have two stories and have the same plan types. Only the difference is the use of infill materials in the construction of the walls. The sensors were placed in the x and y directions at the corner walls inside the houses. They were placed at the top of the second floor and at the top of the first floor. The sensor placements and test equipment are shown in Figures 6 and 7.

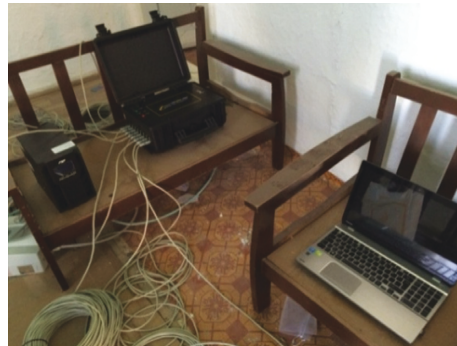
FIGURE 7: The sensor placements and test equipment.

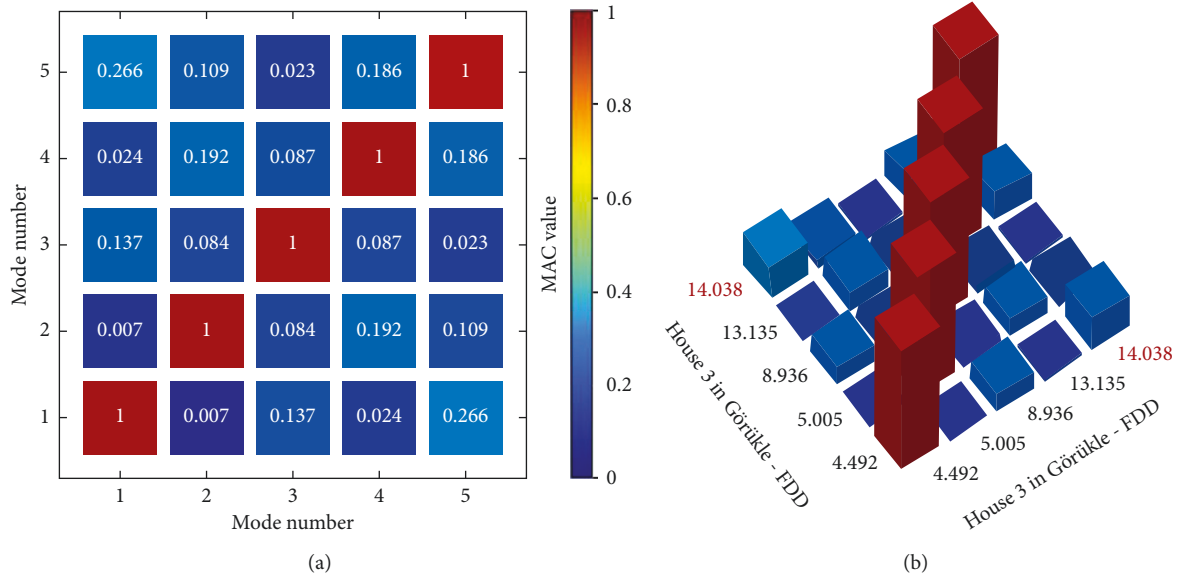
FIGURE 11: (a) 2D and (b) 3D presentation of MAC values of House 3 in Görükle village.

The orthogonality between the modes are checked by using modal assurance criteria (MAC). According to the MAC Values, the experimental modes are independent from one another and a good harmony obtained among natural frequencies and mode shapes. In Figure 11, the 2D and 3D presentation of MAC values belonging to House 3 in Görükle village can be seen. The numerical presentation of MAC values belonging to House 3 in Görükle village is presented in Table 3.
